# Access Compliance Report

## Public Rights-of-Way

| Intersection ID: 32211 | Main Street: DENNINGTON GROVE LN | Cross Street: BRYANT FARMS RD | Location: SW |
| ADA ID: 44A1FE324C20 | Ramp Type: PerpDiag | Initial Pass/Fail: Fail | Overall Compliance: No |

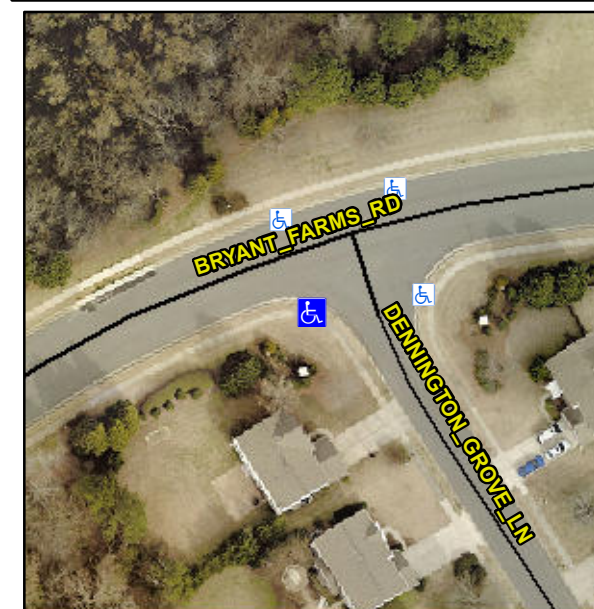
| Codes/Mitigation Info/Possible Solution | | | Severity Score: 35 |

**Not Found, R304.5.1, R304.2.2, R304.5.3**

| Compliance | Description | Data | Compliance | Description | Data |
|---|---|---|---|---|---|
| N/A | Ramp Length (in) | 46.0 | No | Ramp Slope (%) | 14.8 |
| No | Ramp Width (in) | 46.0 | No | Ramp XSlope (%) | 2.2 |

**Remove & Replace Curb Ramp With Two New Directional Ramps or Equivalent.**

Total Cost: \$ 3200.00
