# Access Compliance Report

## Public Rights-of-Way

### (Curb Ramps)

Intersection ID: 15217	Main Street: ALBEMARLE_RD	Cross Street: WINTERHAVEN_DR	Location: NW
ADA ID: 44B037ACDF31	Ramp Type: Perp	Initial Pass/Fail: Fail	Overall Compliance: No
Codes/Mitigation Info/Possible Solution		Field Measurements/Component Compliance

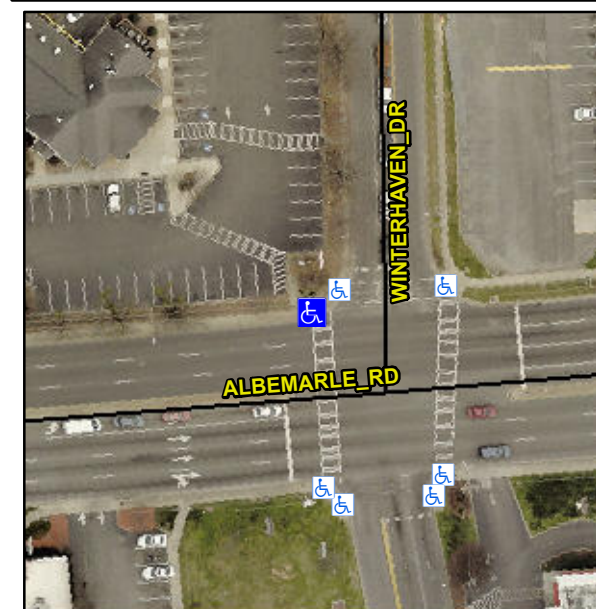
**Not Found, R304.5.1, R304.2.2**

Compliance	Description	Data	Compliance	Description	Data
N/A	Ramp Length (in)	59.0	No	Ramp Slope (%)	11.1
No	Ramp Width (in)	44.0	Yes	Ramp XSlope (%)	1.9
N/A	Flare Type LT	N/A	N/A	Flare Type RT	N/A
N/A	Flare Slope LT (%)	N/A	N/A	Flare Slope RT (%)	N/A
N/A	Flare Traversable LT?	N/A	N/A	Flare Traversable RT?	N/A
N/A	Landing Length (in)	N/A	N/A	DWS Provided?	N/A
N/A	Landing Width (in)	N/A	N/A	DWS Contrast?	N/A
N/A	Landing Slope (%)	N/A	N/A	DWS Length (in)	N/A
N/A	Landing X Slope (%)	N/A	N/A	DWS Full Width?	N/A
N/A	Landing Curb? (Y/N)	N/A	N/A	DWS Offset (in)	N/A
N/A	Shared Landing?	N/A			
N/A	Gutter Ponding?	N/A	N/A	Gutter Slope (%)	N/A
N/A	Gutter Lip Ht (in)	N/A	N/A	Gutter X Slope (%)	N/A
N/A	Painted X Walk1?	Yes	N/A	Painted X Walk2?	N/A
	X Walk 1 Direction	To S		X Walk 2 Direction	N/A
N/A	X Walk 1 Width (in)	105.0	N/A	X Walk 2 Width (in)	N/A
	X Walk 1 Slope (%)	1.1		X Walk 2 Slope (%)	N/A
	X Walk 1 X Slope (%)	0.0		X Walk 2 X Slope (%)	N/A

N/A	Ramp inside XWalk1?	Yes	N/A	Ramp inside XWalk2?	N/A
	Road Slope (%)	N/A	N/A	Clear Space?	N/A
	Road X Slope (%)	N/A	N/A	Clear Space to XWalk (in)	N/A
N/A	Any Obstructions?	N/A	N/A	Storm Grate/Utility Hazard?	N/A
	Obstruction Type			Storm Grate/Utility Type	
		N/A			N/A
			Yes	Surface Condition? (G/P)	Good

**Remove & Replace Entire Ramp.**

Total Cost: \$ 1850.00
