## Access Compliance Report Public Rights-of-Way (Curb Ramps)

Intersection ID: 44337 Main Street: SYCAMORE_CREEK_DR				Cross	Street:	E_ARROWOOD_RD	Location:	NE		
ADA ID: 44C68C277A3	44C68C277A3A Ramp Type: PerpDiag			Initial	Initial Pass/Fail: Fail Overall Compliance: No				o Severity Score:	21.25
Codes/Mitigation Info/Possible Solution					Field Measurements/Component Compliance					
		Possible Solutions:			Compliance Description			Data Compliance Description		
		Remove & Replace Curb Two New Directional Ram	b Ram	o With	N/A	Ramp Length (in)	60.0	No	Ramp Slope (%)	9.2
					No	Ramp Width (in)	40.0	Yes	Ramp XSlope (%)	0.4
		Equivalent.	-		N/A	Flare Type LT	N/A	N/A	Flare Type RT	N/A
	and the state of				N/A	Flare Slope LT (%)	N/A	N/A	Flare Slope RT (%)	N/A
	and the second second				N/A	Flare Traversable LT?	N/A	N/A	Flare Traversable RT?	N/A
	Star 1				N/A	Landing Length (in)	N/A	N/A	DWS Provided?	N/A
Service Falls		Surveyor Notes:			N/A	Landing Width (in)	N/A	N/A	DWS Contrast?	N/A

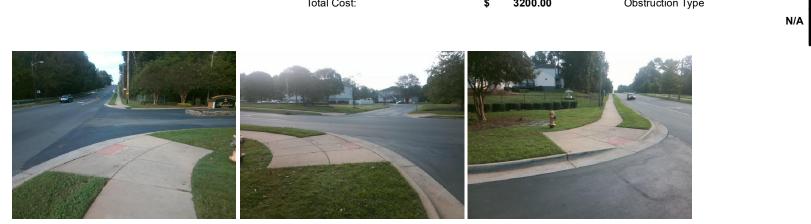
N/A			N/A	Landing Slope (%)	N/A	N/A	DWS Length (in)	N/A	
PROW/ADA: Not Found, R304.5.1, R304.2.2				N/A	Landing X Slope (%)	N/A	N/A	DWS Full Width?	N/A	
				N/A	Landing Curb? (Y/N)	N/A	N/A	DWS Offset (in)	N/A	
				N/A	Shared Landing?	N/A				
					N/A	Gutter Ponding?	N/A	N/A	Gutter Slope (%)	N/A
			)	N/A	Gutter Lip Ht (in)	N/A	N/A	Gutter X Slope (%)	N/A	
					N/A	Painted X Walk1?	No	N/A	Painted X Walk2?	No
						X Walk 1 Direction	To SW		X Walk 2 Direction	To S
					N/A	X Walk 1 Width (in)	N/A	N/A	X Walk 2 Width (in)	N/A
Street 1 Name	SYCAMORE CREEK DR	_				X Walk 1 Slope (%)	0.6		X Walk 2 Slope (%)	5.1
Stop Condition-Street 2	None					X Walk 1 X Slope (%)	0.7		X Walk 2 X Slope (%)	2.0
Street 2 Name	E ARROWOOD RD				N/A	Ramp inside XWalk1?	N/A	N/A	Ramp inside XWalk2?	N/A
Stop Condition-Street 1	None					Road Slope (%)	1.0	N/A	Clear Space?	N/A
						Road X Slope (%)	5.1	N/A	Clear Space to XWalk (in)	N/A

N/A	Any Obstructions?	N/A	N/A	Storm Grate/Utility Hazard?	N/A
		Total Cost:	\$	3200.00		Obstruction Type			Storm Grate/Utility Type	
							N/A		5 51	N/A
								1
