Access Compliance Report

Public Rights-of-Way

(Curb Ramps)

Intersection ID: 15147	Main Street: QUEENS_RD	Cross Street: EDGEHILL_RD_SOUTH	Location: E
ADA ID: 44CE2164A628	Ramp Type: PerpDiag	Initial Pass/Fail: Fail	Overall Compliance: No
Severity Score: 17.5			
Codes/Mitigation Info/Possible Solution		Field Measurements/Component Compliance

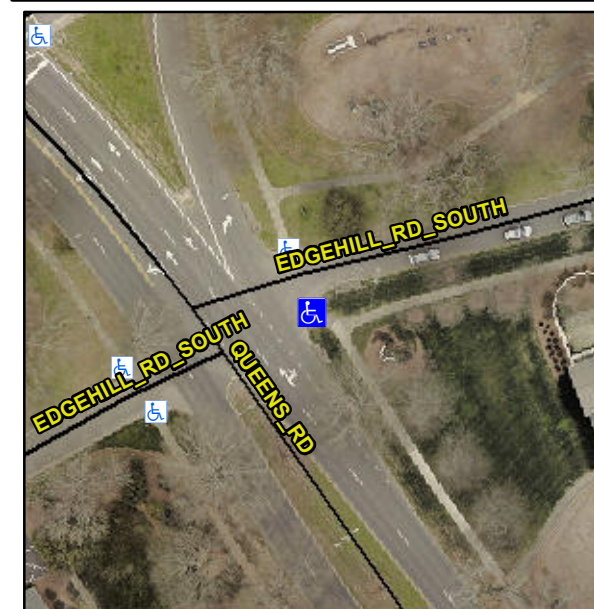
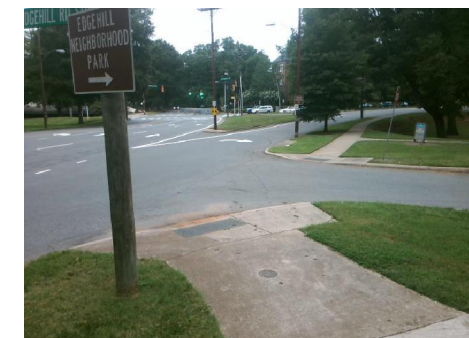
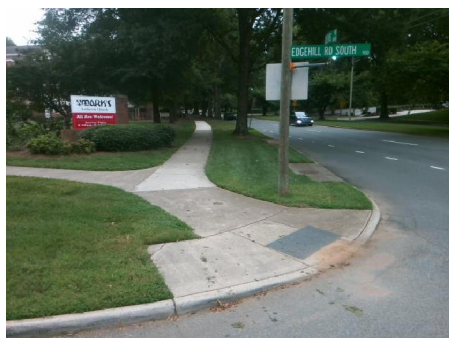
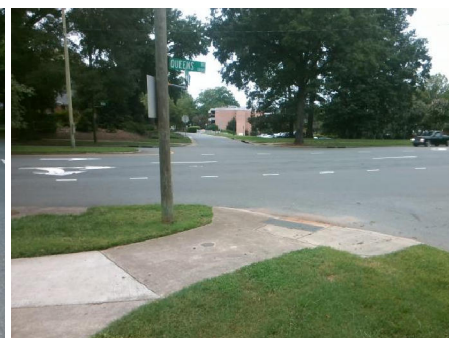
Compliance	Description	Data	Compliance	Description	Data
N/A	Ramp Length (in)	60.0	Yes	Ramp Slope (%)	8.3
No	Ramp Width (in)	35.0	Yes	Ramp XSlope (%)	0.6
N/A	Flare Type LT	N/A	N/A	Flare Type RT	N/A
N/A	Flare Slope LT (%)	N/A	N/A	Flare Slope RT (%)	N/A
N/A	Flare Traversable LT?	N/A	N/A	Flare Traversable RT?	N/A
N/A	Landing Length (in)	N/A	N/A	DWS Provided?	N/A
N/A	Landing Width (in)	N/A	N/A	DWS Contrast?	N/A
N/A	Landing Slope (%)	N/A	N/A	DWS Length (in)	N/A
N/A	Landing X Slope (%)	N/A	N/A	DWS Full Width?	N/A
N/A	Landing Curb? (Y/N)	N/A	N/A	DWS Offset (in)	N/A
N/A	Shared Landing?	N/A			
N/A	Gutter Ponding?	N/A	N/A	Gutter Slope (%)	N/A
N/A	Gutter Lip Ht (in)	N/A	N/A	Gutter X Slope (%)	N/A
N/A	Painted X Walk1?	No	N/A	Painted X Walk2?	No
	X Walk 1 Direction	To N		X Walk 2 Direction	To SW
N/A	X Walk 1 Width (in)	N/A	N/A	X Walk 2 Width (in)	N/A
	X Walk 1 Slope (%)	1.8		X Walk 2 Slope (%)	2.8
	X Walk 1 X Slope (%)	1.1		X Walk 2 X Slope (%)	1.7

N/A	Ramp inside XWalk1?	N/A	N/A	Ramp inside XWalk2?	N/A
	Road Slope (%)	1.9	N/A	Clear Space?	N/A
	Road X Slope (%)	2.5	N/A	Clear Space to XWalk (in)	N/A
N/A	Any Obstructions?	N/A	N/A	Storm Grate/Utility Hazard?	N/A
	Obstruction Type			Storm Grate/Utility Type	
		N/A			N/A
			Yes	Surface Condition? (G/P)	Good

Possible Solutions:

Remove & Replace Curb Ramp With Two New Directional Ramps or Equivalent.

R304.5.1
