# Access Compliance Report

## Public Rights-of-Way

### (Curb Ramps)

| Intersection ID: 12011 | Main Street: E_16TH_ST | Cross Street: HARRILL_ST | Location: E |

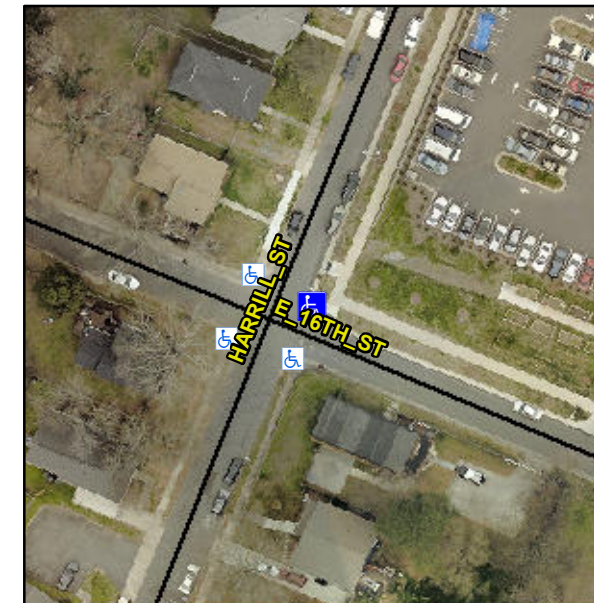
| ADA ID: 44DF627CD143 | Ramp Type: PerpDiag | Initial Pass/Fail: Fail | Overall Compliance: No |

**Not Found, R304.5.1**

| Compliance | Description | Data | Compliance | Description | Data |
|---|---|---|---|---|---|
| No | Ramp Width (in) | 41.0 | Yes | Ramp XSlope (%) | 0.5 |

**Remove & Replace Curb Ramp With Two New Directional Ramps or Equivalent.**

Total Cost: \$ 3200.00
