Access Compliance Report

Public Rights-of-Way

(Curb Ramps)

| Intersection ID: 50320 | | Main Street: BRYN_ATHYN_CT | | Cross Street: CINDY_LN | | Location: NW | | | | | |

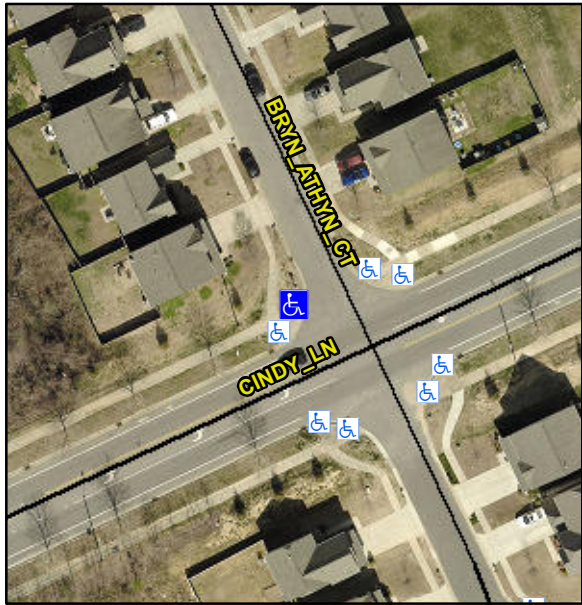
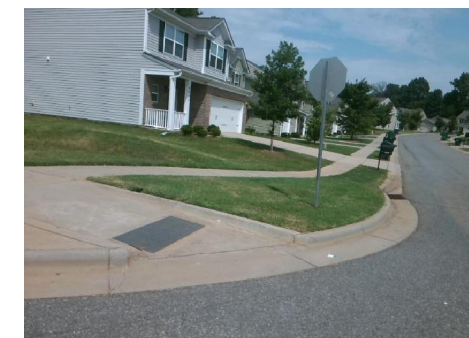
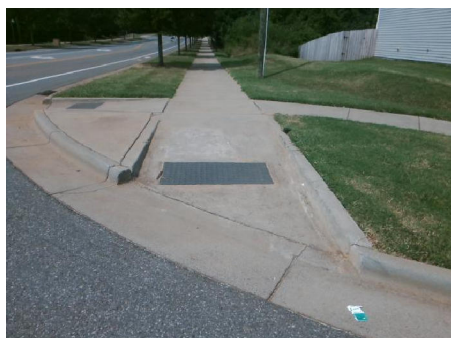
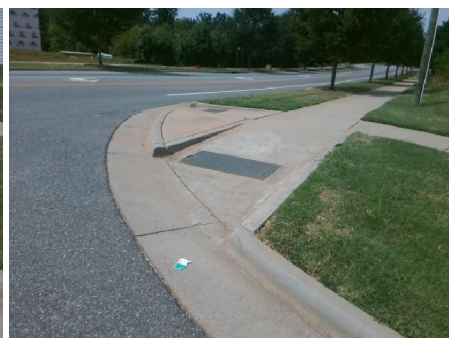
| ADA ID: 44EADD1067A1 | | Ramp Type: Directional1 | | Initial Pass/Fail: Fail | | Overall Compliance: No | | Severity Score: 12.5 | | | |
| | | | | | | No | Ramp Slope (%) | 9.7 | N/A | Grade Break XSlope (%) | 0.0 |

| | | | | Remove & Replace Entire Ramp. | | N/A | Ramp Length (in) | 112.5 | N/A | Grade Break? | N/A |
