Access Compliance Report

Public Rights-of-Way

(Curb Ramps)

Intersection ID: 9425	Main Street: GRIMES_ST	Cross Street: WINSTON_ST	Location: E
ADA ID: 44F7950C37F4	Ramp Type: Combination2	Initial Pass/Fail: Fail	Overall Compliance: No
Severity Score: 36.25			
Codes/Mitigation Info/Possible Solution		Field Measurements/Component Compliance

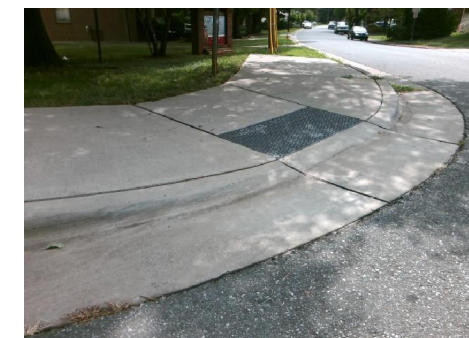
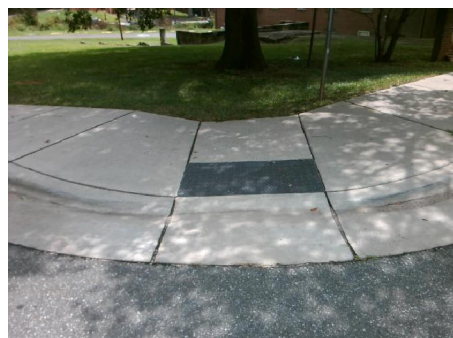
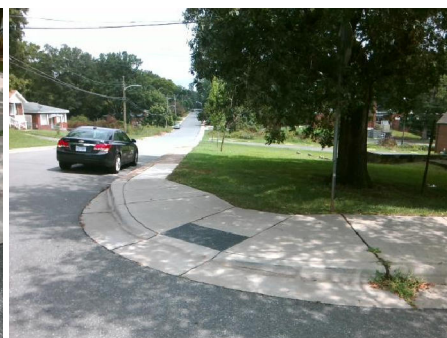
LT RP < 5%

Not Found, R304.5.1, R304.5.1, R304.5.3

Compliance	Description	Data	Compliance	Description	Data
N/A	Ramp Length LT (in)	41.5	N/A	Ramp Length RT (in)	73.5
N/A	Ramp Width LT (in)	72.0	No	Ramp Width RT (in)	31.0
N/A	Ramp Slope LT (%)	1.1	Yes	Ramp Slope RT (%)	5.3
N/A	Ramp XSlope LT (%)	0.9	Yes	Ramp XSlope RT (%)	0.5
N/A	Ramp Length (in)	72.0	Yes	Ramp Slope (%)	1.6
No	Ramp Width (in)	47.5	No	Ramp XSlope (%)	3.9
N/A	Flare Type LT	N/A	N/A	Flare Type RT	N/A
N/A	Flare Slope LT (%)	N/A	N/A	Flare Slope RT (%)	N/A
N/A	Flare Traversable LT?	N/A	N/A	Flare Traversable RT?	N/A
N/A	Landing Length (in)	N/A	N/A	DWS Provided?	N/A
N/A	Landing Width (in)	N/A	N/A	DWS Contrast?	N/A
N/A	Landing Slope (%)	N/A	N/A	DWS Length (in)	N/A
N/A	Landing X Slope (%)	N/A	N/A	DWS Full Width?	N/A
N/A	Landing Curb? (Y/N)	N/A	N/A	DWS Offset (in)	N/A
N/A	Shared Landing?	N/A			
N/A	Gutter Ponding?	N/A	N/A	Gutter Slope (%)	N/A
N/A	Gutter Lip Ht (in)	N/A	N/A	Gutter X Slope (%)	N/A
N/A	Painted X Walk1?	No	N/A	Painted X Walk2?	N/A

X Walk 1 Direction	To SW		X Walk 2 Direction	N/A
	X Walk 1 Width (in)	N/A		X Walk 2 Width (in)	N/A
	X Walk 1 Slope (%)	5.2		X Walk 2 Slope (%)	N/A
	X Walk 1 X Slope (%)	1.8		X Walk 2 X Slope (%)	N/A
N/A	Ramp inside XWalk1?	N/A	N/A	Ramp inside XWalk2?	N/A
	Road Slope (%)	N/A		Clear Space?	N/A
	Road X Slope (%)	N/A	N/A	Clear Space to XWalk (in)	N/A
			N/A	Any Obstruction?	N/A
				Obstruction Type	N/A
			N/A	Storm Grate/Utility Hazard?	N/A
				Storm Grate/Utility Type	N/A
			Yes	Surface Condition? (G/P)	Good
				Curb Slope (%)	21.4

Possible Solutions:

Remove & Replace Entire Ramp.
