Intersection ID: 8679	Main Street: HATERAS_AV	Cross Street: NEWCASTLE_ST	Location:	SW
ADA ID: 44FE1C2D06A3	Ramp Type: Perp	Initial Pass/Fail: Fail	Overall Compliance: No	Severity Score: 30

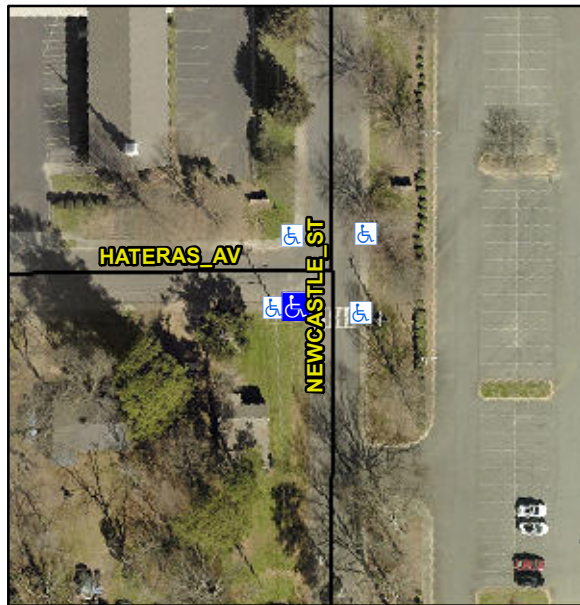
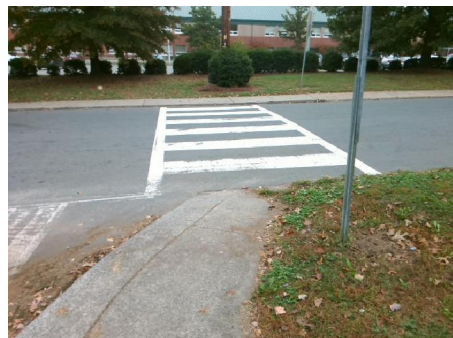
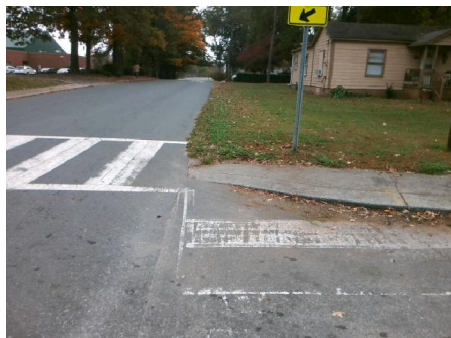
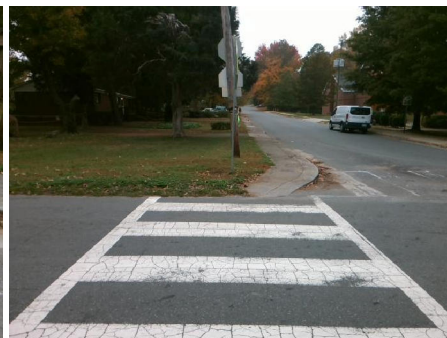
Possible Solutions:			Compliance	Description	Data	Compliance	Description	Data
<div>Remove & Replace Entire Ramp.</div> <div>Surveyor Notes:</div> <div>N/A</div> <div>PROW/ADA:</div> <div>R304.5.1, R304.2.2</div>			N/A	Ramp Length (in)	36.0	No	Ramp Slope (%)	10.0
			No	Ramp Width (in)	33.0	Yes	Ramp XSlope (%)	0.6
			N/A	Flare Type LT	N/A	N/A	Flare Type RT	N/A
			N/A	Flare Slope LT (%)	N/A	N/A	Flare Slope RT (%)	N/A
			N/A	Flare Traversable LT?	N/A	N/A	Flare Traversable RT?	N/A
			N/A	Landing Length (in)	N/A	N/A	DWS Provided?	N/A
			N/A	Landing Width (in)	N/A	N/A	DWS Contrast?	N/A
			N/A	Landing Slope (%)	N/A	N/A	DWS Length (in)	N/A
			N/A	Landing X Slope (%)	N/A	N/A	DWS Full Width?	N/A
			N/A	Landing Curb? (Y/N)	N/A	N/A	DWS Offset (in)	N/A
			N/A	Shared Landing?	N/A			
			N/A	Gutter Ponding?	Yes	N/A	Gutter Slope (%)	N/A
			N/A	Gutter Lip Ht (in)	1.5	N/A	Gutter X Slope (%)	N/A
			N/A	Painted X Walk1?	Yes	N/A	Painted X Walk2?	N/A

X Walk 1 Direction	To E		X Walk 2 Direction	N/A
N/A	X Walk 1 Width (in)	111.0	N/A	X Walk 2 Width (in)	N/A			
	X Walk 1 Slope (%)	1.5		X Walk 2 Slope (%)	N/A			
	X Walk 1 X Slope (%)	1.9		X Walk 2 X Slope (%)	N/A			
N/A	Ramp inside XWalk1?	Yes	N/A	Ramp inside XWalk2?	N/A			
	Road Slope (%)	N/A	N/A	Clear Space?	N/A			
	Road X Slope (%)	N/A	N/A	Clear Space to XWalk (in)	N/A			
N/A	Any Obstructions?	N/A	N/A	Storm Grate/Utility Hazard?	N/A			
Total Cost:	\$	1850.00		Obstruction Type		Storm Grate/Utility Type		
					N/A			N/A
						Yes	Surface Condition? (G/P)	Good

Remove & Replace Entire Ramp.

R304.5.1, R304.2.2
