Access Compliance Report

Public Rights-of-Way

(Curb Ramps)

Intersection ID: 53880	Main Street: PAWTUCKETT_RD	Cross Street: PAW_VILLAGE_RD	Location:	S
ADA ID: 450425FB0AA8	Ramp Type: Perp	Initial Pass/Fail: Fail	Overall Compliance: No	Severity Score: 10

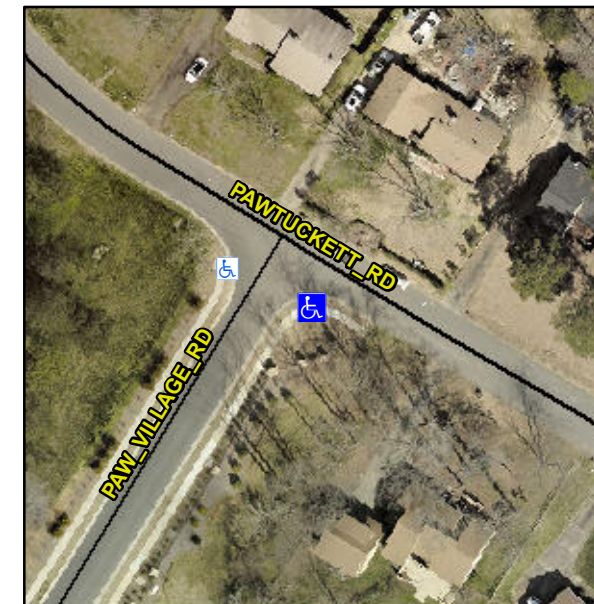
Compliance	Description	Data	Compliance	Description	Data
N/A	Ramp Length (in)	47.0	Yes	Ramp Slope (%)	5.6
No	Ramp Width (in)	45.0	No	Ramp XSlope (%)	3.1
N/A	Flare Type LT	N/A	N/A	Flare Type RT	N/A
N/A	Flare Slope LT (%)	N/A	N/A	Flare Slope RT (%)	N/A
N/A	Flare Traversable LT?	N/A	N/A	Flare Traversable RT?	N/A
N/A	Landing Length (in)	N/A	N/A	DWS Provided?	N/A
N/A	Landing Width (in)	N/A	N/A	DWS Contrast?	N/A
N/A	Landing Slope (%)	N/A	N/A	DWS Length (in)	N/A
N/A	Landing X Slope (%)	N/A	N/A	DWS Full Width?	N/A
N/A	Landing Curb? (Y/N)	N/A	N/A	DWS Offset (in)	N/A
N/A	Shared Landing?	N/A			
N/A	Gutter Ponding?	N/A	N/A	Gutter Slope (%)	N/A
N/A	Gutter Lip Ht (in)	N/A	N/A	Gutter X Slope (%)	N/A
N/A	Painted X Walk1?	No	N/A	Painted X Walk2?	N/A
	X Walk 1 Direction	To NW		X Walk 2 Direction	N/A
N/A	X Walk 1 Width (in)	N/A	N/A	X Walk 2 Width (in)	N/A
	X Walk 1 Slope (%)	5.7		X Walk 2 Slope (%)	N/A
	X Walk 1 X Slope (%)	0.2		X Walk 2 X Slope (%)	N/A

N/A	Ramp inside XWalk1?	N/A	N/A	Ramp inside XWalk2?	N/A
	Road Slope (%)	N/A	N/A	Clear Space?	N/A
	Road X Slope (%)	N/A	N/A	Clear Space to XWalk (in)	N/A
N/A	Any Obstructions?	N/A	N/A	Storm Grate/Utility Hazard?	N/A
	Obstruction Type			Storm Grate/Utility Type	
		N/A			N/A
			Yes	Surface Condition? (G/P)	Good

Possible Solutions:

Remove & Replace Entire Ramp.

R304.5.1, R304.5.3
