# Access Compliance Report

## Public Rights-of-Way

### (Curb Ramps)

Intersection ID: 50736	Main Street: JONES RIDGE DR	Cross Street: PROVIDENCE LN WEST	Location: N
ADA ID: 450FC5D8E665	Ramp Type: PerpDiag	Initial Pass/Fail: Fail	Overall Compliance: No
Severity Score: 21.25			
Codes/Mitigation Info/Possible Solution		Field Measurements/Component Compliance

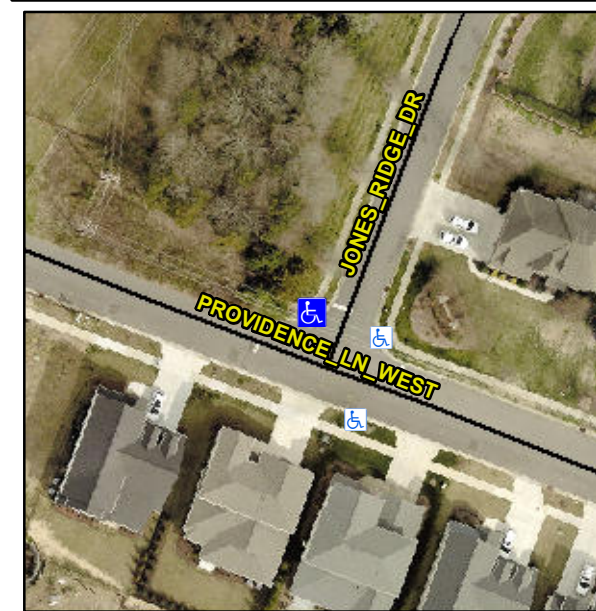
**Not Found, R304.5.1, R304.5.3**

Compliance	Description	Data	Compliance	Description	Data
N/A	Ramp Length (in)	44.0	Yes	Ramp Slope (%)	5.7
No	Ramp Width (in)	39.0	No	Ramp XSlope (%)	5.4
N/A	Flare Type LT	N/A	N/A	Flare Type RT	N/A
N/A	Flare Slope LT (%)	N/A	N/A	Flare Slope RT (%)	N/A
N/A	Flare Traversable LT?	N/A	N/A	Flare Traversable RT?	N/A
N/A	Landing Length (in)	N/A	N/A	DWS Provided?	N/A
N/A	Landing Width (in)	N/A	N/A	DWS Contrast?	N/A
N/A	Landing Slope (%)	N/A	N/A	DWS Length (in)	N/A
N/A	Landing X Slope (%)	N/A	N/A	DWS Full Width?	N/A
N/A	Landing Curb? (Y/N)	N/A	N/A	DWS Offset (in)	N/A
N/A	Shared Landing?	N/A			
N/A	Gutter Ponding?	N/A	N/A	Gutter Slope (%)	N/A
N/A	Gutter Lip Ht (in)	N/A	N/A	Gutter X Slope (%)	N/A
N/A	Painted X Walk1?	No	N/A	Painted X Walk2?	No
	X Walk 1 Direction	To SW		X Walk 2 Direction	To SE
N/A	X Walk 1 Width (in)	N/A	N/A	X Walk 2 Width (in)	N/A
	X Walk 1 Slope (%)	0.0		X Walk 2 Slope (%)	3.1
	X Walk 1 X Slope (%)	1.9		X Walk 2 X Slope (%)	4.9

N/A	Ramp inside XWalk1?	N/A	N/A	Ramp inside XWalk2?	N/A
	Road Slope (%)	4.0	N/A	Clear Space?	N/A
	Road X Slope (%)	1.4	N/A	Clear Space to XWalk (in)	N/A
N/A	Any Obstructions?	N/A	N/A	Storm Grate/Utility Hazard?	N/A
	Obstruction Type			Storm Grate/Utility Type	
		N/A			N/A
			Yes	Surface Condition? (G/P)	Good

**Remove & Replace Curb Ramp With Two New Directional Ramps or Equivalent.**
