# Access Compliance Report

## Public Rights-of-Way

### (Curb Ramps)

Intersection ID: 10067	Main Street: ETHEL_GUEST_LN	Cross Street: OAKLAWN_AV	Location: NW
ADA ID: 451E78D5DC31	Ramp Type: PerpDiag	Initial Pass/Fail: Fail	Overall Compliance: No
Severity Score: 12.5			
Codes/Mitigation Info/Possible Solution		Field Measurements/Component Compliance

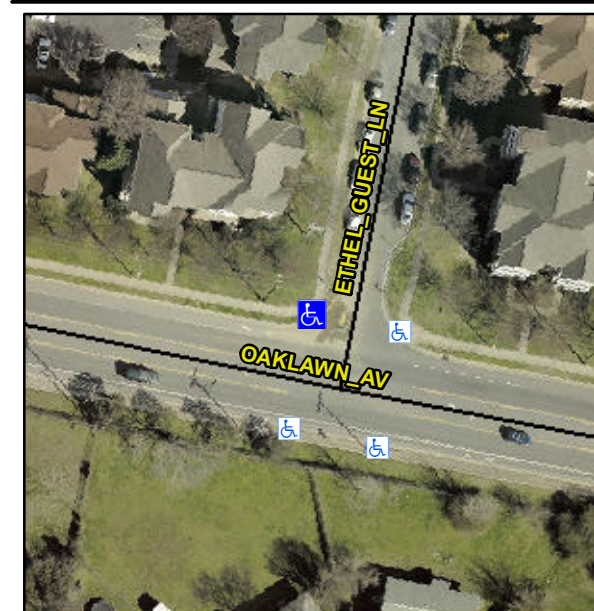
Compliance	Description	Data	Compliance	Description	Data
N/A	Ramp Length (in)	45.0	No	Ramp Slope (%)	10.2
Yes	Ramp Width (in)	54.0	Yes	Ramp XSlope (%)	1.9
N/A	Flare Type LT	N/A	N/A	Flare Type RT	N/A
N/A	Flare Slope LT (%)	N/A	N/A	Flare Slope RT (%)	N/A
N/A	Flare Traversable LT?	N/A	N/A	Flare Traversable RT?	N/A
N/A	Landing Length (in)	N/A	N/A	DWS Provided?	N/A
N/A	Landing Width (in)	N/A	N/A	DWS Contrast?	N/A
N/A	Landing Slope (%)	N/A	N/A	DWS Length (in)	N/A
N/A	Landing X Slope (%)	N/A	N/A	DWS Full Width?	N/A
N/A	Landing Curb? (Y/N)	N/A	N/A	DWS Offset (in)	N/A
N/A	Shared Landing?	N/A			
N/A	Gutter Ponding?	N/A	N/A	Gutter Slope (%)	N/A
N/A	Gutter Lip Ht (in)	N/A	N/A	Gutter X Slope (%)	N/A
N/A	Painted X Walk1?	No	N/A	Painted X Walk2?	No
	X Walk 1 Direction	To SW		X Walk 2 Direction	To SE
N/A	X Walk 1 Width (in)	N/A	N/A	X Walk 2 Width (in)	N/A
	X Walk 1 Slope (%)	3.3		X Walk 2 Slope (%)	2.9
	X Walk 1 X Slope (%)	1.3		X Walk 2 X Slope (%)	4.8

N/A	Ramp inside XWalk1?	N/A	N/A	Ramp inside XWalk2?	N/A
	Road Slope (%)	2.8	N/A	Clear Space?	N/A
	Road X Slope (%)	7.8	N/A	Clear Space to XWalk (in)	N/A
N/A	Any Obstructions?	N/A	N/A	Storm Grate/Utility Hazard?	N/A
	Obstruction Type			Storm Grate/Utility Type	
		N/A			N/A
		Yes		Surface Condition? (G/P)	Good

Possible Solutions:

**Remove & Replace Curb Ramp With Two New Directional Ramps or Equivalent.**

**Not Found, R304.2.2**
