# Access Compliance Report

## Public Rights-of-Way

### (Curb Ramps)

Intersection ID: 13149	Main Street: CENTRAL_AV	Cross Street: THE_PLAZA	Location: NE
ADA ID: 451EA7D7F799	Ramp Type: Perp	Initial Pass/Fail: Fail	Overall Compliance: No
Severity Score: 17.5			
Codes/Mitigation Info/Possible Solution		Field Measurements/Component Compliance

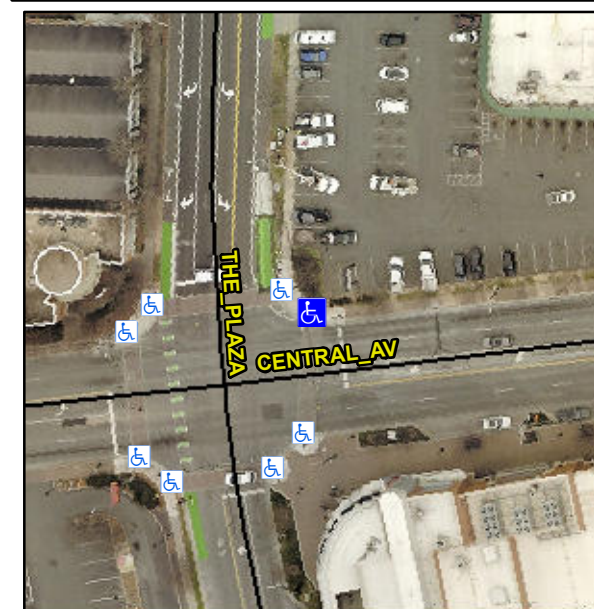
Compliance	Description	Data	Compliance	Description	Data
N/A	Ramp Length (in)	74.0	Yes	Ramp Slope (%)	7.7
No	Ramp Width (in)	34.0	Yes	Ramp XSlope (%)	1.5
N/A	Flare Type LT	N/A	N/A	Flare Type RT	N/A
N/A	Flare Slope LT (%)	N/A	N/A	Flare Slope RT (%)	N/A
N/A	Flare Traversable LT?	N/A	N/A	Flare Traversable RT?	N/A
N/A	Landing Length (in)	N/A	N/A	DWS Provided?	N/A
N/A	Landing Width (in)	N/A	N/A	DWS Contrast?	N/A
N/A	Landing Slope (%)	N/A	N/A	DWS Length (in)	N/A
N/A	Landing X Slope (%)	N/A	N/A	DWS Full Width?	N/A
N/A	Landing Curb? (Y/N)	N/A	N/A	DWS Offset (in)	N/A
N/A	Shared Landing?	N/A			
N/A	Gutter Ponding?	N/A	N/A	Gutter Slope (%)	N/A
N/A	Gutter Lip Ht (in)	N/A	N/A	Gutter X Slope (%)	N/A
N/A	Painted X Walk1?	Yes	N/A	Painted X Walk2?	N/A
	X Walk 1 Direction	To S		X Walk 2 Direction	N/A
N/A	X Walk 1 Width (in)	96.0	N/A	X Walk 2 Width (in)	N/A
	X Walk 1 Slope (%)	1.3		X Walk 2 Slope (%)	N/A
	X Walk 1 X Slope (%)	1.4		X Walk 2 X Slope (%)	N/A

N/A	Ramp inside XWalk1?	Yes	N/A	Ramp inside XWalk2?	N/A
	Road Slope (%)	N/A	N/A	Clear Space?	N/A
	Road X Slope (%)	N/A	N/A	Clear Space to XWalk (in)	N/A
N/A	Any Obstructions?	N/A	N/A	Storm Grate/Utility Hazard?	N/A
	Obstruction Type			Storm Grate/Utility Type	
		N/A			N/A
		Yes		Surface Condition? (G/P)	Good

Possible Solutions:

**Remove & Replace Entire Ramp.**

**Not Found, R304.5.1**

Total Cost: \$ 1850.00
