Access Compliance Report

Public Rights-of-Way

(Curb Ramps)

Intersection ID: 23329	Main Street: GLENEAGLES_RD	Cross Street: PARK_RD	Location: SW
ADA ID: 45230876C1A6	Ramp Type: PerpDiag	Initial Pass/Fail: Fail	Overall Compliance: No
Severity Score: 35			
Codes/Mitigation Info/Possible Solution		Field Measurements/Component Compliance

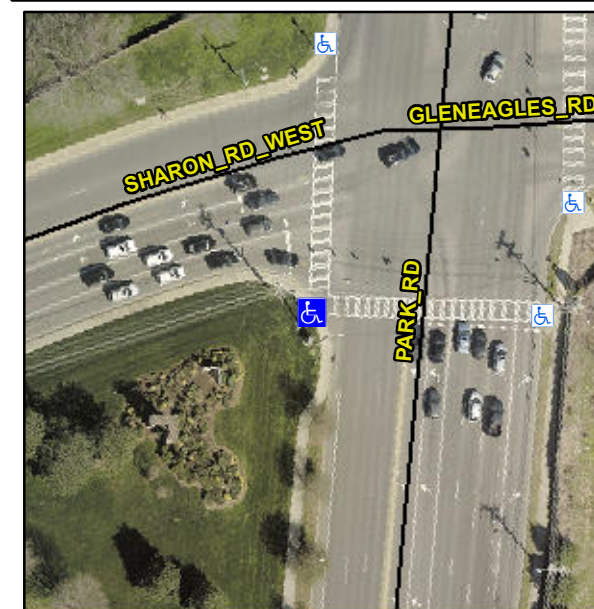
Not Found, R304.5.1

Compliance	Description	Data	Compliance	Description	Data
N/A	Ramp Length (in)	59.0	Yes	Ramp Slope (%)	7.6
No	Ramp Width (in)	30.0	Yes	Ramp XSlope (%)	1.2
N/A	Flare Type LT	N/A	N/A	Flare Type RT	N/A
N/A	Flare Slope LT (%)	N/A	N/A	Flare Slope RT (%)	N/A
N/A	Flare Traversable LT?	N/A	N/A	Flare Traversable RT?	N/A
N/A	Landing Length (in)	N/A	N/A	DWS Provided?	N/A
N/A	Landing Width (in)	N/A	N/A	DWS Contrast?	N/A
N/A	Landing Slope (%)	N/A	N/A	DWS Length (in)	N/A
N/A	Landing X Slope (%)	N/A	N/A	DWS Full Width?	N/A
N/A	Landing Curb? (Y/N)	N/A	N/A	DWS Offset (in)	N/A
N/A	Shared Landing?	N/A			
N/A	Gutter Ponding?	N/A	N/A	Gutter Slope (%)	N/A
N/A	Gutter Lip Ht (in)	N/A	N/A	Gutter X Slope (%)	N/A
N/A	Painted X Walk1?	Yes	N/A	Painted X Walk2?	Yes
	X Walk 1 Direction	To SE		X Walk 2 Direction	To NE
N/A	X Walk 1 Width (in)	108.0	N/A	X Walk 2 Width (in)	110.0
	X Walk 1 Slope (%)	2.3		X Walk 2 Slope (%)	0.6
	X Walk 1 X Slope (%)	2.6		X Walk 2 X Slope (%)	2.9

N/A	Ramp inside XWalk1?	Yes	N/A	Ramp inside XWalk2?	Yes
	Road Slope (%)	3.9	N/A	Clear Space?	N/A
	Road X Slope (%)	5.3	N/A	Clear Space to XWalk (in)	N/A
N/A	Any Obstructions?	N/A	N/A	Storm Grate/Utility Hazard?	N/A
	Obstruction Type			Storm Grate/Utility Type	
		N/A			N/A
		Yes		Surface Condition? (G/P)	Good

Remove & Replace Curb Ramp With Two New Directional Ramps or Equivalent.

Total Cost: \$ 3200.00
