# Access Compliance Report

### (Curb Ramps)

| Intersection ID: 27907 | Main Street: BAY_HILL_CLUB_DR | Cross Street: COLONIAL_COUNTRY_LN | Location: | N |
| ADA ID: 452B6C96759E | Ramp Type: Perp | Initial Pass/Fail: Fail | Overall Compliance: No | Severity Score: 1.25 |

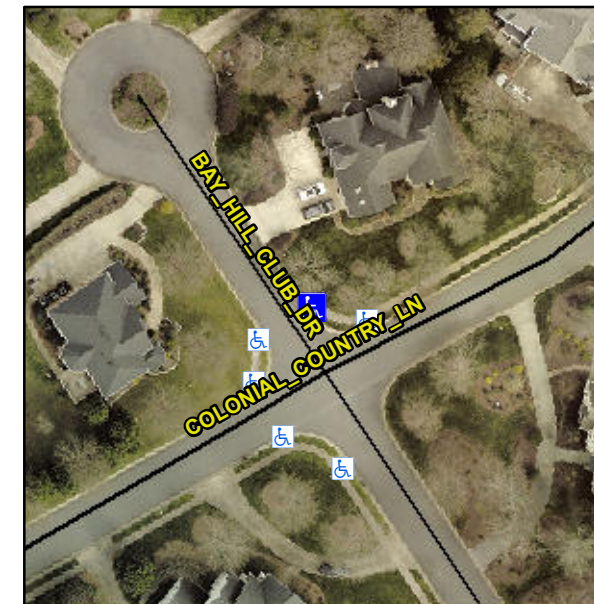
Surveyor Notes:

**N/A**

PROW/ADA:

**R304.5.3**

| Compliance | Description | Data | Compliance | Description | Data |
|---|---|---|---|---|---|
| Yes | Ramp Width (in) | 49.0 | No | Ramp XSlope (%) | 2.6 |

Possible Solutions:

**Remove & Replace Entire Ramp.**

Total Cost:

**\$ 1850.00**
