Access Compliance Report

Public Rights-of-Way

(Curb Ramps)

Intersection ID: 26392	Main Street: BEVINGTON_PL	Cross Street: BRECHIN_DR	Location: S
ADA ID: 453B2CB2C5C5	Ramp Type: Perp	Initial Pass/Fail: Fail	Overall Compliance: No
Codes/Mitigation Info/Possible Solution		Field Measurements/Component Compliance	
Severity Score: 26.25

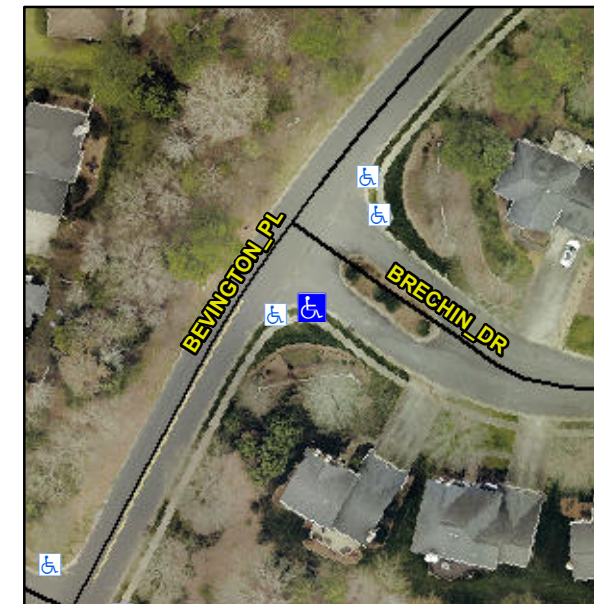
Not Found, R304.2.2, R304.5.3

Compliance	Description	Data	Compliance	Description	Data
N/A	Ramp Length (in)	46.0	No	Ramp Slope (%)	12.2
Yes	Ramp Width (in)	48.0	No	Ramp XSlope (%)	2.4
N/A	Flare Type LT	N/A	N/A	Flare Type RT	N/A
N/A	Flare Slope LT (%)	N/A	N/A	Flare Slope RT (%)	N/A
N/A	Flare Traversable LT?	N/A	N/A	Flare Traversable RT?	N/A
N/A	Landing Length (in)	N/A	N/A	DWS Provided?	N/A
N/A	Landing Width (in)	N/A	N/A	DWS Contrast?	N/A
N/A	Landing Slope (%)	N/A	N/A	DWS Length (in)	N/A
N/A	Landing X Slope (%)	N/A	N/A	DWS Full Width?	N/A
N/A	Landing Curb? (Y/N)	N/A	N/A	DWS Offset (in)	N/A
N/A	Shared Landing?	N/A			
N/A	Gutter Ponding?	N/A	N/A	Gutter Slope (%)	N/A
N/A	Gutter Lip Ht (in)	N/A	N/A	Gutter X Slope (%)	N/A
N/A	Painted X Walk1?	No	N/A	Painted X Walk2?	N/A
	X Walk 1 Direction	To NE		X Walk 2 Direction	N/A
N/A	X Walk 1 Width (in)	N/A	N/A	X Walk 2 Width (in)	N/A
	X Walk 1 Slope (%)	1.2		X Walk 2 Slope (%)	N/A
	X Walk 1 X Slope (%)	3.6		X Walk 2 X Slope (%)	N/A

N/A	Ramp inside XWalk1?	N/A	N/A	Ramp inside XWalk2?	N/A
	Road Slope (%)	N/A	N/A	Clear Space?	N/A
	Road X Slope (%)	N/A	N/A	Clear Space to XWalk (in)	N/A
N/A	Any Obstructions?	N/A	N/A	Storm Grate/Utility Hazard?	N/A
	Obstruction Type			Storm Grate/Utility Type	
		N/A			N/A
			Yes	Surface Condition? (G/P)	Good

Remove & Replace Entire Ramp.
