Access Compliance Report

Public Rights-of-Way

(Curb Ramps)

Intersection ID: 50041	Main Street: METROPOLITAN_AV	Cross Street: CHARLOTTETOWNE_AV	Location: SW
ADA ID: 453C892A66C4	Ramp Type: Perp	Initial Pass/Fail: Fail	Overall Compliance: No
		Severity Score: 12.5

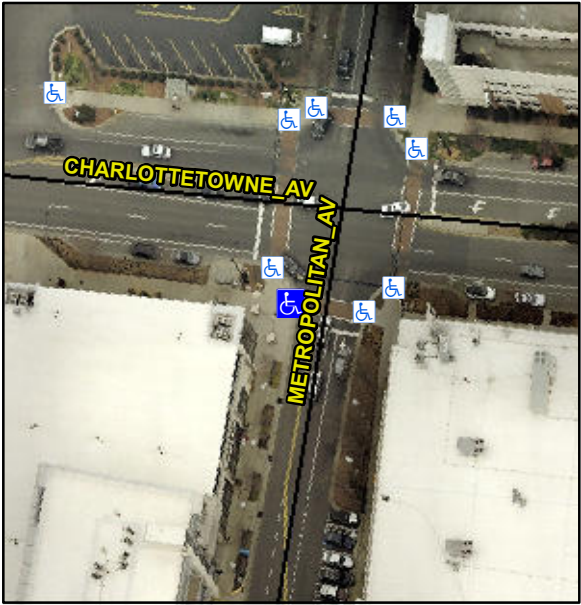
Possible Solutions:		Compliance	Description	Data
	Remove & Replace Entire Ramp.		No	Ramp Length (in)	75.0
			Yes	Ramp Width (in)	48.0
			N/A	Flare Type LT	N/A
			N/A	Flare Slope LT (%)	N/A
			N/A	Flare Traversable LT?	N/A
			N/A	Landing Length (in)	N/A
			N/A	Landing Width (in)	N/A
			N/A	Landing Slope (%)	N/A
			N/A	Landing X Slope (%)	N/A
<p>Surveyor Notes:</p> <p>N/A</p> <p>PROW/ADA:</p> <p>R304.2.2</p>			N/A	Flare Type RT	N/A
			N/A	Flare Slope RT (%)	N/A
			N/A	Flare Traversable RT?	N/A
			N/A	DWS Provided?	N/A
			N/A	DWS Contrast?	N/A
			N/A	DWS Length (in)	N/A
			N/A	DWS Full Width?	N/A
			N/A	DWS Offset (in)	N/A
			N/A	Gutter Ponding?	N/A
			N/A	Gutter Lip Ht (in)	N/A
<p>Total Cost:</p> <p>\$ 1850.00</p>			Yes	Painted X Walk1?	N/A
			To E	X Walk 1 Direction	N/A
			N/A	X Walk 1 Width (in)	97.0

4.2	X Walk 1 Slope (%)	N/A
			1.8	X Walk 1 X Slope (%)	N/A
			N/A	Ramp inside XWalk1?	Yes
			N/A	Road Slope (%)	N/A
			N/A	Road X Slope (%)	N/A
			N/A	Any Obstructions?	N/A
			N/A	Obstruction Type	N/A
			N/A	Clear Space?	N/A
			N/A	Clear Space to XWalk (in)	N/A
			N/A	Storm Grate/Utility Hazard?	N/A
			N/A	Storm Grate/Utility Type	N/A
			Yes	Surface Condition? (G/P)	Good
