# Access Compliance Report

## Public Rights-of-Way

### (Curb Ramps)

Intersection ID: 10023803	Main Street: COLONY_RD	Cross Street: N/A	Location: SE
ADA ID: 4543A0D227D9	Ramp Type: PerpDiag	Initial Pass/Fail: Fail	Overall Compliance: No
			Severity Score: 13.75

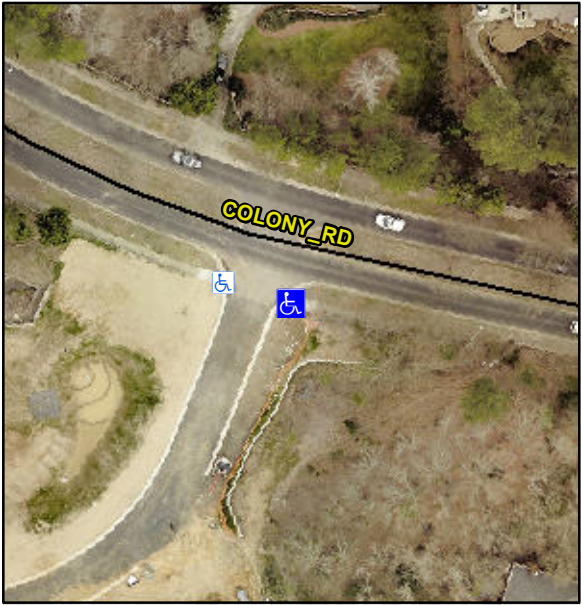
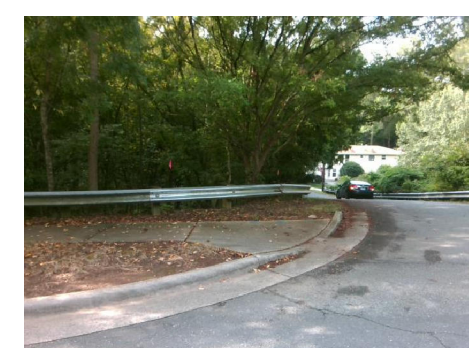
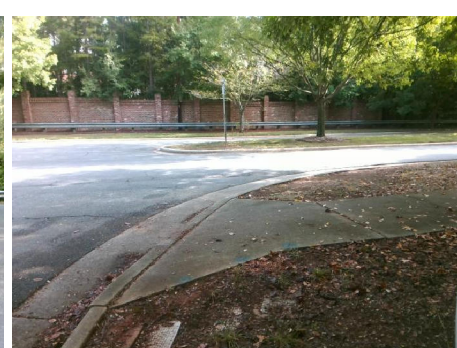
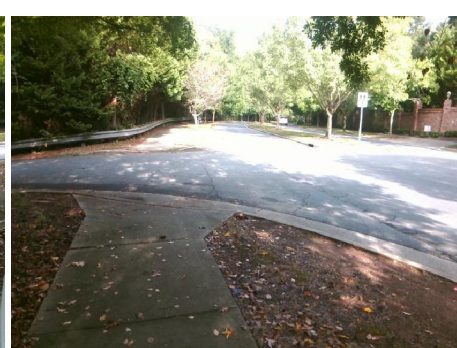
Possible Solutions:						
	<b>Remove &amp; Replace Curb Ramp With Two New Directional Ramps or Equivalent.</b>						
	Surveyor Notes:						
	<b>N/A</b>						
	PROW/ADA:						
	<b>Not Found, R304.2.2, R304.5.3</b>						
		<b>Compliance</b>	<b>Description</b>	<b>Data</b>	<b>Compliance</b>	<b>Description</b>	<b>Data</b>
		N/A	Ramp Length (in)	61.0	No	Ramp Slope (%)	9.5
		Yes	Ramp Width (in)	53.0	No	Ramp XSlope (%)	2.2
		N/A	Flare Type LT	N/A	N/A	Flare Type RT	N/A
		N/A	Flare Slope LT (%)	N/A	N/A	Flare Slope RT (%)	N/A
		N/A	Flare Traversable LT?	N/A	N/A	Flare Traversable RT?	N/A
		N/A	Landing Length (in)	N/A	N/A	DWS Provided?	N/A
		N/A	Landing Width (in)	N/A	N/A	DWS Contrast?	N/A
		N/A	Landing Slope (%)	N/A	N/A	DWS Length (in)	N/A
		N/A	Landing X Slope (%)	N/A	N/A	DWS Full Width?	N/A
		N/A	Landing Curb? (Y/N)	N/A	N/A	DWS Offset (in)	N/A

N/A	Shared Landing?	N/A			
		N/A	Gutter Ponding?	N/A	N/A	Gutter Slope (%)	N/A
		N/A	Gutter Lip Ht (in)	N/A	N/A	Gutter X Slope (%)	N/A
		N/A	Painted X Walk1?	No	N/A	Painted X Walk2?	No
			X Walk 1 Direction	To N		X Walk 2 Direction	To NW
		N/A	X Walk 1 Width (in)	N/A	N/A	X Walk 2 Width (in)	N/A
			X Walk 1 Slope (%)	0.5		X Walk 2 Slope (%)	2.8
			X Walk 1 X Slope (%)	1.3		X Walk 2 X Slope (%)	0.3
		N/A	Ramp inside XWalk1?	N/A	N/A	Ramp inside XWalk2?	N/A
			Road Slope (%)	1.9	N/A	Clear Space?	N/A
			Road X Slope (%)	2.8	N/A	Clear Space to XWalk (in)	N/A
		N/A	Any Obstructions?	N/A	N/A	Storm Grate/Utility Hazard?	N/A
			Obstruction Type			Storm Grate/Utility Type	
					N/A		N/A
					Yes	Surface Condition? (G/P)	Good
Total Cost:		\$	3200.00
