Access Compliance Report

Public Rights-of-Way

(Curb Ramps)

Intersection ID: N/A	Main Street: TWITTER_LN	Cross Street: ROCKY_RIVER_RD	Location: NW
ADA ID: 454CA4B29F14	Ramp Type: Para	Initial Pass/Fail: Fail	Overall Compliance: No
Codes/Mitigation Info/Possible Solution		Field Measurements/Component Compliance	
Severity Score: 12.5

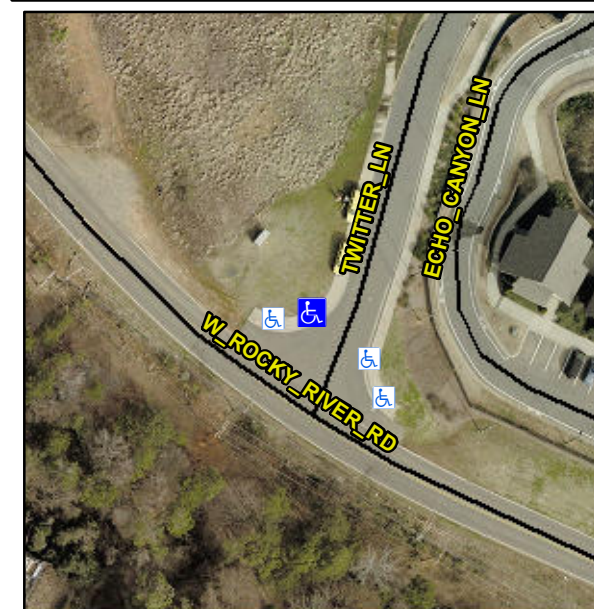
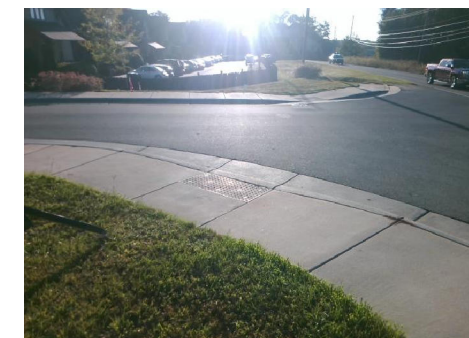
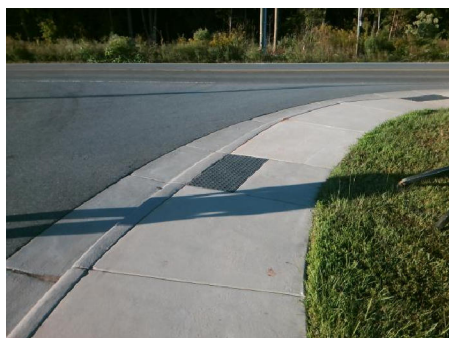
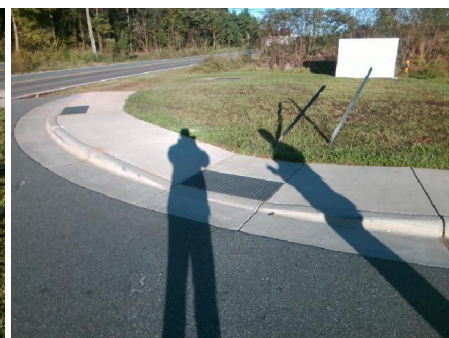
RT RP < 5%

R304.3.2

Compliance	Description	Data	Compliance	Description	Data
N/A	Ramp Length LT (in)	57.0	N/A	Ramp Length RT (in)	56.0
Yes	Ramp Width LT (in)	60.0	Yes	Ramp Width RT (in)	60.0
No	Ramp Slope LT (%)	11.2	Yes	Ramp Slope RT (%)	4.3
Yes	Ramp XSlope LT (%)	0.4	Yes	Ramp XSlope RT (%)	1.8
N/A	Landing Length (in)	N/A	N/A	DWS Provided?	N/A
N/A	Landing Width (in)	N/A	N/A	DWS Contrast?	N/A
N/A	Landing Slope (%)	N/A	N/A	DWS Length (in)	N/A
N/A	Landing X Slope (%)	N/A	N/A	DWS Full Width?	N/A
N/A	Landing Curb? (Y/N)	N/A	N/A	DWS Offset (in)	N/A
N/A	Shared Landing?	N/A			
N/A	Gutter Ponding?	N/A	N/A	Gutter Slope (%)	N/A
N/A	Gutter Lip Ht (in)	N/A	N/A	Gutter X Slope (%)	N/A
N/A	Painted X Walk1?	No	N/A	Painted X Walk2?	N/A
	X Walk 1 Direction	To E		X Walk 2 Direction	N/A
N/A	X Walk 1 Width (in)	N/A	N/A	X Walk 2 Width (in)	N/A
	X Walk 1 Slope (%)	1.6		X Walk 2 Slope (%)	N/A
	X Walk 1 X Slope (%)	1.5		X Walk 2 X Slope (%)	N/A
N/A	Ramp inside XWalk1?	N/A	N/A	Ramp inside XWalk2?	N/A

Road Slope (%)	N/A	N/A	Clear Space?	N/A
	Road X Slope (%)	N/A	N/A	Clear Space to XWalk (in)	N/A
N/A	Any Obstructions?	N/A	N/A	Storm Grate/Utility Hazard?	N/A
	Obstruction Type			Storm Grate/Utility Type	
		N/A			N/A
			Yes	Surface Condition? (G/P)	Good
			N/A	Curb Slope (%)	0.7

Remove & Replace Entire Ramp.
