Intersection ID: 45793	Main Street: WINDING_RIVER_DR	Cross Street: GRANITE_TRAIL_LN	Location:	NE
ADA ID: 455BE9C13D69	Ramp Type: PerpDiag	Initial Pass/Fail: Fail	Overall Compliance: No	Severity Score: 8.75

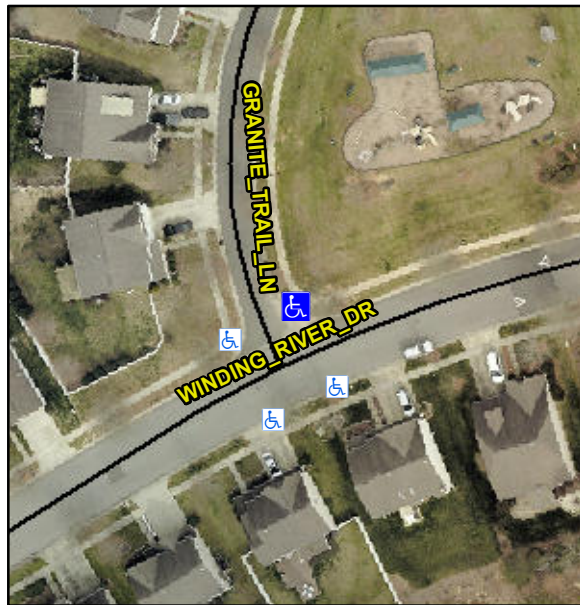
Not Found, R304.5.1

Possible Solutions:			Compliance	Description	Data	Compliance	Description	Data
Remove & Replace Curb Ramp With Two New Directional Ramps or Equivalent.	N/A	Ramp Length (in)	75.0	Yes	Ramp Slope (%)	6.2		
	No	Ramp Width (in)	47.0	Yes	Ramp XSlope (%)	1.5		
	N/A	Flare Type LT	N/A	N/A	Flare Type RT	N/A		
	N/A	Flare Slope LT (%)	N/A	N/A	Flare Slope RT (%)	N/A		
	N/A	Flare Traversable LT?	N/A	N/A	Flare Traversable RT?	N/A		
	N/A	Landing Length (in)	N/A	N/A	DWS Provided?	N/A		
	N/A	Landing Width (in)	N/A	N/A	DWS Contrast?	N/A		
	N/A	Landing Slope (%)	N/A	N/A	DWS Length (in)	N/A		
	N/A	Landing X Slope (%)	N/A	N/A	DWS Full Width?	N/A		
	N/A	Landing Curb? (Y/N)	N/A	N/A	DWS Offset (in)	N/A		
Surveyor Notes: N/A	N/A	Shared Landing?	N/A					
	N/A	Gutter Ponding?	N/A	N/A	Gutter Slope (%)	N/A		
	N/A	Gutter Lip Ht (in)	N/A	N/A	Gutter X Slope (%)	N/A		
	N/A	Painted X Walk1?	No	N/A	Painted X Walk2?	No		
		X Walk 1 Direction	To W		X Walk 2 Direction	To S

N/A	X Walk 1 Width (in)	N/A	N/A	X Walk 2 Width (in)	N/A		
		X Walk 1 Slope (%)	0.8		X Walk 2 Slope (%)	2.8		
		X Walk 1 X Slope (%)	2.1		X Walk 2 X Slope (%)	1.0		
	N/A	Ramp inside XWalk1?	N/A	N/A	Ramp inside XWalk2?	N/A		
		Road Slope (%)	0.4	N/A	Clear Space?	N/A		
PROW/ADA: Not Found, R304.5.1		Road X Slope (%)	0.9	N/A	Clear Space to XWalk (in)	N/A		
	N/A	Any Obstructions?	N/A	N/A	Storm Grate/Utility Hazard?	N/A		
		Obstruction Type			Storm Grate/Utility Type			
			N/A			N/A		
Total Cost:		\$	3200.00		Yes	Surface Condition? (G/P)	Good

Remove & Replace Curb Ramp With Two New Directional Ramps or Equivalent.
