# Access Compliance Report

## Public Rights-of-Way

| Intersection ID: 43659 | Main Street: TAYLOR RIDGE LN | Cross Street: STARR NEELY RD | Location: SE |
| ADA ID: 4573BB8EC181 | Ramp Type: PerpDiag | Initial Pass/Fail: Pass | Overall Compliance: No |

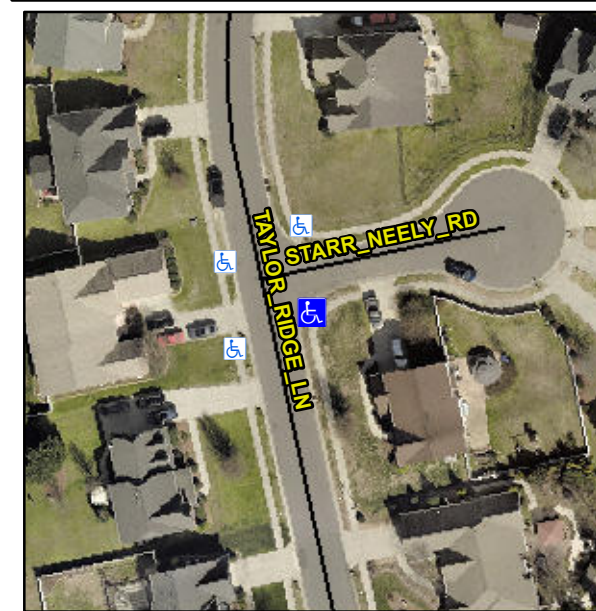
**Not Found, R304.5.3, R304.2.2-Perp, R304.3.2-Para, R305, R302.7.2**

| Compliance | Description | Data | Compliance | Description | Data |
|---|---|---|---|---|---|
| N/A | Ramp Length (in) | 47.0 | Yes | Ramp Slope (%) | 6.6 |
| Yes | Ramp Width (in) | 82.0 | No | Ramp XSlope (%) | 3.6 |
| Yes | Landing Length (in) | 48.0 | No | DWS Provided? | No |
| No | Landing Slope (%) | 3.8 | N/A | DWS Length (in) | N/A |
| No | Gutter Lip Ht (in) | 1.5 | No | Gutter X Slope (%) | 3.2 |

**Remove & Replace Curb Ramp With Two New Directional Ramps or Equivalent. Remove & Replace Gutter.**

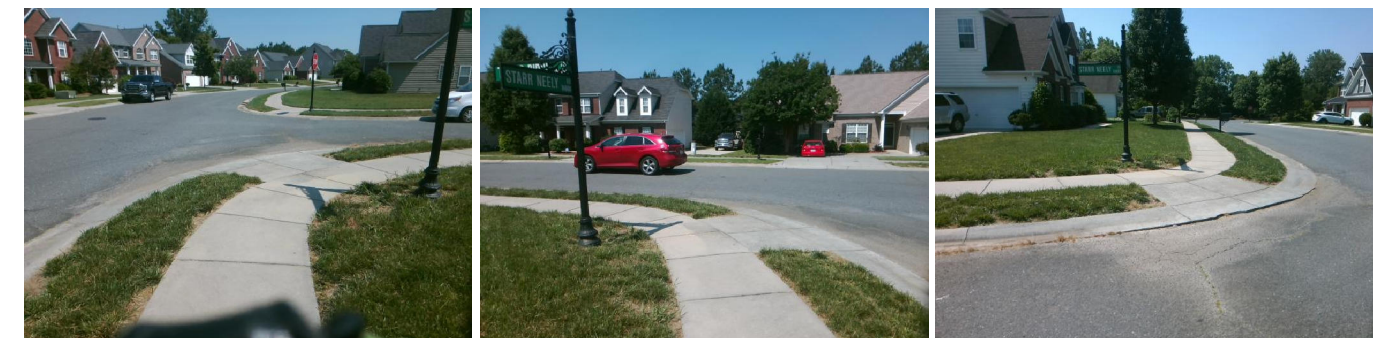
Street 1 Name **STARR NEELY RD**  
 Stop Condition-Street 2 **StopSign**  
 Street 2 Name **TATLOR RIDGE LN**  
 Stop Condition-Street 1 **None**
