Access Compliance Report

Public Rights-of-Way

(Curb Ramps)

Intersection ID: N/A	Main Street: CALDWELL_RD	Cross Street: SUNBURST_LN	Location: E
ADA ID: 457E2F22CCF5	Ramp Type: PerpDiag	Initial Pass/Fail: Fail	Overall Compliance: No
		Severity Score: 10

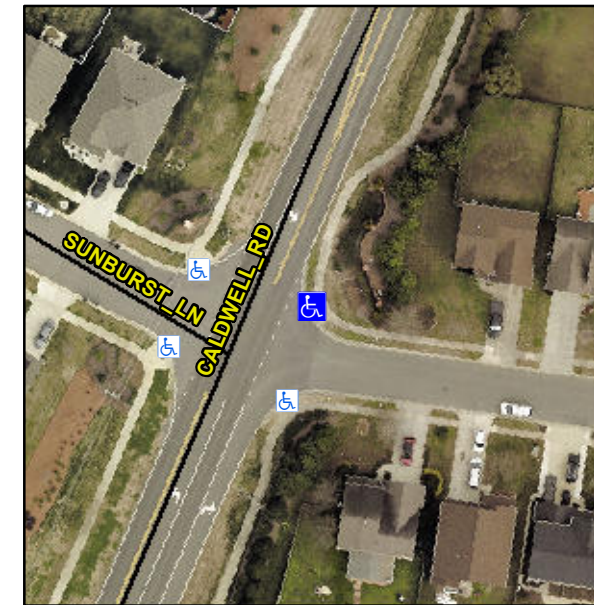
Compliance	Description	Data	Compliance	Description	Data
N/A	Ramp Length (in)	48.0	Yes	Ramp Slope (%)	6.1
No	Ramp Width (in)	42.5	No	Ramp XSlope (%)	2.3
N/A	Flare Type LT	N/A	N/A	Flare Type RT	N/A
N/A	Flare Slope LT (%)	N/A	N/A	Flare Slope RT (%)	N/A
N/A	Flare Traversable LT?	N/A	N/A	Flare Traversable RT?	N/A
N/A	Landing Length (in)	N/A	N/A	DWS Provided?	N/A
N/A	Landing Width (in)	N/A	N/A	DWS Contrast?	N/A
N/A	Landing Slope (%)	N/A	N/A	DWS Length (in)	N/A
N/A	Landing X Slope (%)	N/A	N/A	DWS Full Width?	N/A
N/A	Landing Curb? (Y/N)	N/A	N/A	DWS Offset (in)	N/A
N/A	Shared Landing?	N/A			
N/A	Gutter Ponding?	N/A	N/A	Gutter Slope (%)	N/A
N/A	Gutter Lip Ht (in)	N/A	N/A	Gutter X Slope (%)	N/A
N/A	Painted X Walk1?	No	N/A	Painted X Walk2?	No
	X Walk 1 Direction	To NW		X Walk 2 Direction	To SW
N/A	X Walk 1 Width (in)	N/A	N/A	X Walk 2 Width (in)	N/A
	X Walk 1 Slope (%)	4.5		X Walk 2 Slope (%)	3.4
	X Walk 1 X Slope (%)	3.4		X Walk 2 X Slope (%)	3.1

N/A	Ramp inside XWalk1?	N/A	N/A	Ramp inside XWalk2?	N/A
	Road Slope (%)	0.7	N/A	Clear Space?	N/A
	Road X Slope (%)	6.5	N/A	Clear Space to XWalk (in)	N/A
N/A	Any Obstructions?	N/A	N/A	Storm Grate/Utility Hazard?	N/A
	Obstruction Type			Storm Grate/Utility Type	
		N/A			N/A
		Yes		Surface Condition? (G/P)	Good

Remove & Replace Curb Ramp With Two New Directional Ramps or Equivalent.

R304.5.1, R304.5.3
