Access Compliance Report

Public Rights-of-Way

(Curb Ramps)

Intersection ID: 15568	Main Street: KENILWORTH_AV	Cross Street: ORDERMORE_AV	Location: NE
ADA ID: 458A4CF71D4C	Ramp Type: Directional1	Initial Pass/Fail: Fail	Overall Compliance: No
Severity Score: 33.75			
Codes/Mitigation Info/Possible Solution		Field Measurements/Component Compliance

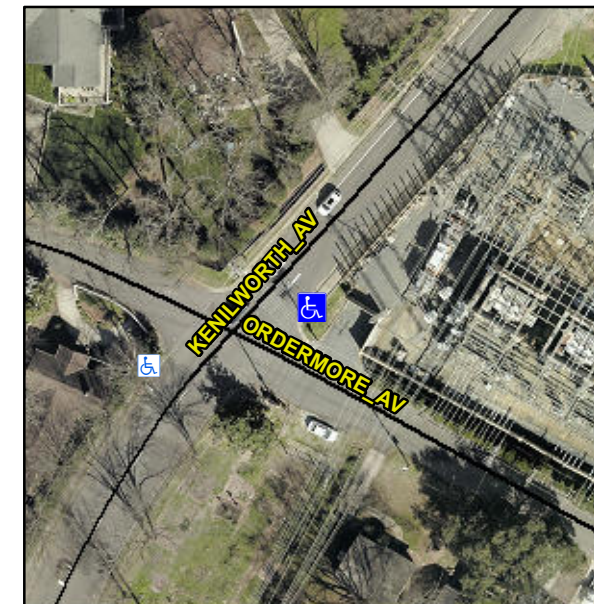
Compliance	Description	Data	Compliance	Description	Data
N/A	Ramp Length (in)	56.0	N/A	Grade Break?	N/A
No	Ramp Width (in)	44.0	N/A	Grade Break Slope (%)	0.0
No	Ramp Slope (%)	19.9	N/A	Grade Break XSlope (%)	0.0
Yes	Ramp XSlope (%)	1.7			
N/A	Flare Type LT	N/A	N/A	Flare Type RT	N/A
N/A	Flare Slope LT (%)	N/A	N/A	Flare Slope RT (%)	0.0
N/A	Flare Traversable LT?	N/A	N/A	Flare Traversable RT?	N/A
N/A	Landing Length (in)	0.0	N/A	DWS Provided?	N/A
N/A	Landing Width (in)	0.0	N/A	DWS Contrast?	N/A
N/A	Landing Slope (%)	0.0	N/A	DWS Length (in)	N/A
N/A	Landing X Slope (%)	0.0	N/A	DWS Full Width?	N/A
N/A	Landing Curb? (Y/N)	N/A	N/A	DWS Offset LT (in)	N/A
N/A	Shared Landing?	N/A	N/A	DWS Offset RT (in)	N/A
N/A	Gutter Ponding?	0.0	N/A	Gutter Slope (%)	N/A
N/A	Gutter Lip Ht (in)	0.0	N/A	Gutter X Slope (%)	N/A
N/A	Painted X Walk1?	No		Road Slope (%)	7.3
	X Walk 1 Direction	To NW		Road X Slope (%)	8.8
	X Walk 1 Width (in)	N/A		Clear Space?	N/A

X Walk 1 Slope (%)	7.3	N/A	Clear Space to XWalk (in)	N/A
	X Walk 1 X Slope (%)	8.8	N/A	Storm Grate/Utility Hazard?	N/A
N/A	Ramp inside XWalk1?	N/A		Storm Grate/Utility Type	
N/A	Any Obstructions?	N/A			N/A
	Obstruction Type		Yes	Surface Condition? (G/P)	Good
			N/A	Curb Slope (%)	17.6

Possible Solutions:

Remove & Replace Entire Ramp.
