# Access Compliance Report

## Public Rights-of-Way

### (Curb Ramps)

Intersection ID: N/A	Main Street: HOOVER_CREEK_BV	Cross Street: STEELECROFT_PY	Location: SW
ADA ID: 45995389E4CF	Ramp Type: Perp	Initial Pass/Fail: Fail	Overall Compliance: No
Severity Score: 12.5			
Codes/Mitigation Info/Possible Solution		Field Measurements/Component Compliance

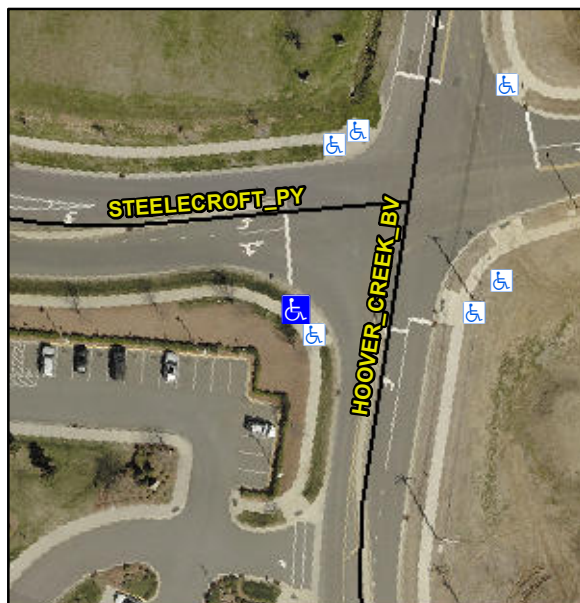
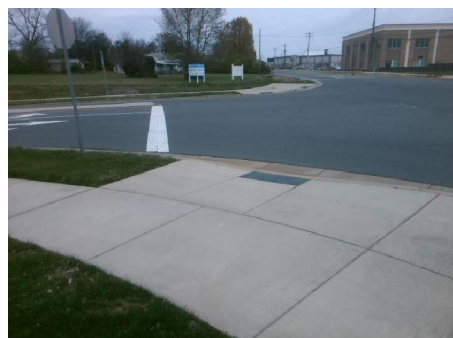
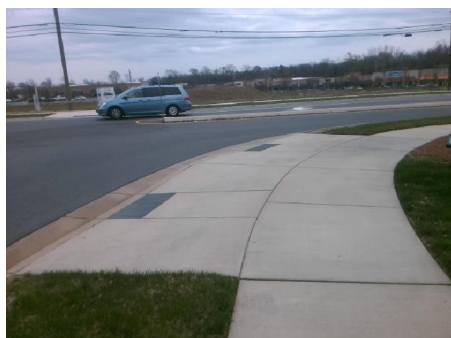
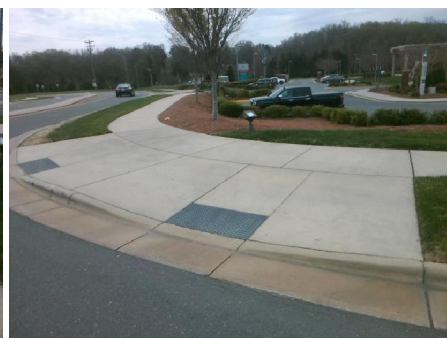
**Not Found, R304.2.2**

Compliance	Description	Data	Compliance	Description	Data
N/A	Ramp Length (in)	94.0	No	Ramp Slope (%)	8.5
Yes	Ramp Width (in)	48.0	Yes	Ramp XSlope (%)	1.3
N/A	Flare Type LT	N/A	N/A	Flare Type RT	N/A
N/A	Flare Slope LT (%)	N/A	N/A	Flare Slope RT (%)	N/A
N/A	Flare Traversable LT?	N/A	N/A	Flare Traversable RT?	N/A
N/A	Landing Length (in)	N/A	N/A	DWS Provided?	N/A
N/A	Landing Width (in)	N/A	N/A	DWS Contrast?	N/A
N/A	Landing Slope (%)	N/A	N/A	DWS Length (in)	N/A
N/A	Landing X Slope (%)	N/A	N/A	DWS Full Width?	N/A
N/A	Landing Curb? (Y/N)	N/A	N/A	DWS Offset (in)	N/A
N/A	Shared Landing?	N/A			
N/A	Gutter Ponding?	N/A	N/A	Gutter Slope (%)	N/A
N/A	Gutter Lip Ht (in)	N/A	N/A	Gutter X Slope (%)	N/A
N/A	Painted X Walk1?	No	N/A	Painted X Walk2?	N/A
	X Walk 1 Direction	To NE		X Walk 2 Direction	N/A
N/A	X Walk 1 Width (in)	N/A	N/A	X Walk 2 Width (in)	N/A
	X Walk 1 Slope (%)	1.9		X Walk 2 Slope (%)	N/A
	X Walk 1 X Slope (%)	0.2		X Walk 2 X Slope (%)	N/A

N/A	Ramp inside XWalk1?	N/A	N/A	Ramp inside XWalk2?	N/A
	Road Slope (%)	N/A	N/A	Clear Space?	N/A
	Road X Slope (%)	N/A	N/A	Clear Space to XWalk (in)	N/A
N/A	Any Obstructions?	N/A	N/A	Storm Grate/Utility Hazard?	N/A
	Obstruction Type			Storm Grate/Utility Type	
		N/A			N/A
			Yes	Surface Condition? (G/P)	Good

**Remove & Replace Entire Ramp.**
