Access Compliance Report

Public Rights-of-Way

(Curb Ramps)

Intersection ID: 10148	Main Street: TUCKASEEGEE_RD	Cross Street: MARMAC_RD	Location: NE
ADA ID: 45A8B02ABB0D	Ramp Type: BlendTrans1	Initial Pass/Fail: Fail	Overall Compliance: No
Severity Score: 8.75			
Codes/Mitigation Info/Possible Solution		Field Measurements/Component Compliance

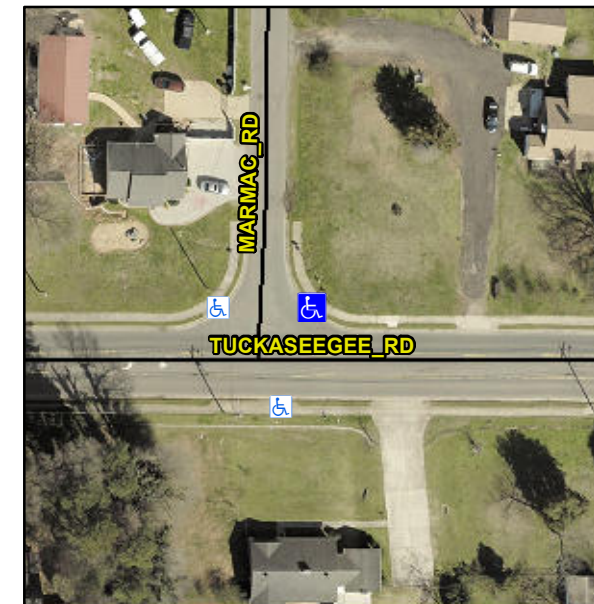
Not Found, R304.5.1

Compliance	Description	Data	Compliance	Description	Data
N/A	Ramp Length (in)	83.5	Yes	BlendTrans Slope (%)	3.8
No	Ramp Width (in)	38.5	Yes	BlendTrans XSlope (%)	0.2
N/A	Flare Type LT	N/A	N/A	Flare Type RT	N/A
N/A	Flare Slope LT (%)	N/A	N/A	Flare Slope RT (%)	N/A
N/A	Flare Traversable LT?	N/A	N/A	Flare Traversable RT?	N/A
N/A	Landing Length (in)	N/A	N/A	DWS Provided?	N/A
N/A	Landing Width (in)	N/A	N/A	DWS Contrast?	N/A
N/A	Landing Slope (%)	N/A	N/A	DWS Length (in)	N/A
N/A	Landing X Slope (%)	N/A	N/A	DWS Full Width?	N/A
N/A	Landing Curb? (Y/N)	N/A	N/A	DWS Offset (in)	N/A
N/A	Shared Landing?	N/A			
N/A	Gutter Ponding?	N/A	N/A	Gutter Slope (%)	N/A
N/A	Gutter Lip Ht (in)	N/A	N/A	Gutter X Slope (%)	N/A
N/A	Painted X Walk1?	No	N/A	Painted X Walk2?	No
	X Walk 1 Direction	To W		X Walk 2 Direction	To S
	X Walk 1 Width (in)	N/A		X Walk 2 Width (in)	N/A
	X Walk 1 Slope (%)	3.4		X Walk 2 Slope (%)	0.7
	X Walk 1 X Slope (%)	0.6		X Walk 2 X Slope (%)	1.9

N/A	Ramp inside XWalk1?	N/A	N/A	Ramp inside XWalk2?	N/A
	Road Slope (%)	0.5		Clear Space?	N/A
	Road X Slope (%)	2.4	N/A	Clear Space to XWalk (in)	N/A
N/A	Any Obstructions?	N/A	N/A	Storm Grate/Utility Hazard?	N/A
	Obstruction Type			Storm Grate/Utility Type	
		N/A			N/A
			Yes	Surface Condition? (G/P)	Good
			No	Curb Slope (%)	17.7

Possible Solutions:

Remove & Replace Curb Ramp With Two New Directional Ramps or Equivalent.
