## **Access Compliance Report Public Rights-of-Way** (Curb Ramps)

Intersection ID: 47844 Main Street: DEL RIO RD **Cross Street: SERAPE RD** Location: NE ADA ID: 45C13A076214 Ramp Type: PerpDiag Initial Pass/Fail: Fail **Overall Compliance: No Severity Score:** 8.75

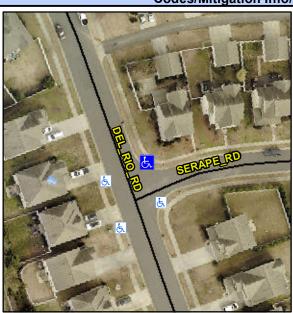
Compliance Description Data			Compliance Description		Data	
N	I/A	Ramp Length (in)	64.0	Yes	Ramp Slope (%)	6.9
N	lo	Ramp Width (in)	47.0	Yes	Ramp XSlope (%)	0.8
N	l/A	Flare Type LT	N/A	N/A	Flare Type RT	N/A
N	I/A	Flare Slope LT (%)	N/A	N/A	Flare Slope RT (%)	N/A
N	I/A	Flare Traversable LT?	N/A	N/A	Flare Traversable RT?	N/A
N	I/A	Landing Length (in)	N/A	N/A	DWS Provided?	N/A
N	I/A	Landing Width (in)	N/A	N/A	DWS Contrast?	N/A
N	I/A	Landing Slope (%)	N/A	N/A	DWS Length (in)	N/A
N	I/A	Landing X Slope (%)	N/A	N/A	DWS Full Width?	N/A
N	I/A	Landing Curb? (Y/N)	N/A	N/A	DWS Offset (in)	N/A
N	I/A	Shared Landing?	N/A			
N	I/A	Gutter Ponding?	N/A	N/A	Gutter Slope (%)	N/A
N	l/A	Gutter Lip Ht (in)	N/A	N/A	Gutter X Slope (%)	N/A
N	I/A	Painted X Walk1?	No	N/A	Painted X Walk2?	No
		X Walk 1 Direction	To W		X Walk 2 Direction	To S
N	I/A	X Walk 1 Width (in)	N/A	N/A	X Walk 2 Width (in)	N/A
		X Walk 1 Slope (%)	0.1		X Walk 2 Slope (%)	0.2

X Walk 1 X Slope (%)	0.6		X Walk 2 X Slope (%)	0.5
N	I/A	Ramp inside XWalk1?	N/A	N/A	Ramp inside XWalk2?	N/A
		Road Slope (%)	1.1	N/A	Clear Space?	N/A
		Road X Slope (%)	1.6	N/A	Clear Space to XWalk (in)	N/A
N	I/A	Any Obstructions?	N/A	N/A	Storm Grate/Utility Hazard?	N/A
		Obstruction Type			Storm Grate/Utility Type	
			N/A			N/A
				Yes	Surface Condition? (G/P)	Good

Possible Solutions: **Remove & Replace Curb Ramp With** Two New Directional Ramps or Equivalent. Surveyor Notes: N/A PROW/ADA: Not Found, R304.5.1
