# Access Compliance Report

## Public Rights-of-Way

### (Curb Ramps)

Intersection ID: 20684	Main Street: PARK_SOUTH_DR	Cross Street: STOKES_AV	Location: SE
ADA ID: 45CC34311E6B	Ramp Type: BlendTrans2	Initial Pass/Fail: Fail	Overall Compliance: No
Severity Score: 8.75			
Codes/Mitigation Info/Possible Solution		Field Measurements/Component Compliance

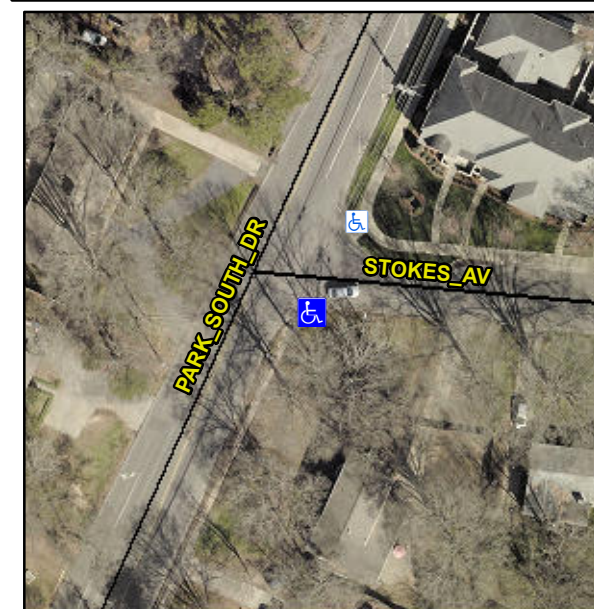
**Not Found, R304.5.1**

Compliance	Description	Data	Compliance	Description	Data
N/A	Ramp Length (in)	64.0	Yes	BlendTrans Slope (%)	3.0
No	Ramp Width (in)	47.0	Yes	BlendTrans XSlope (%)	1.6
N/A	Flare Type LT	N/A	N/A	Flare Type RT	N/A
N/A	Flare Slope LT (%)	N/A	N/A	Flare Slope RT (%)	N/A
N/A	Flare Traversable LT?	N/A	N/A	Flare Traversable RT?	N/A
N/A	Landing Length (in)	N/A	N/A	DWS Provided?	N/A
N/A	Landing Width (in)	N/A	N/A	DWS Contrast?	N/A
N/A	Landing Slope (%)	N/A	N/A	DWS Length (in)	N/A
N/A	Landing X Slope (%)	N/A	N/A	DWS Full Width?	N/A
N/A	Landing Curb? (Y/N)	N/A	N/A	DWS Offset (in)	N/A
N/A	Shared Landing?	N/A			
N/A	Gutter Ponding?	N/A	N/A	Gutter Slope (%)	N/A
N/A	Gutter Lip Ht (in)	N/A	N/A	Gutter X Slope (%)	N/A
N/A	Painted X Walk1?	No	N/A	Painted X Walk2?	No
	X Walk 1 Direction	To NE		X Walk 2 Direction	To W
	X Walk 1 Width (in)	N/A		X Walk 2 Width (in)	N/A
	X Walk 1 Slope (%)	3.6		X Walk 2 Slope (%)	3.5
	X Walk 1 X Slope (%)	2.1		X Walk 2 X Slope (%)	2.6

N/A	Ramp inside XWalk1?	N/A	N/A	Ramp inside XWalk2?	N/A
	Road Slope (%)	1.6		Clear Space?	N/A
	Road X Slope (%)	3.7	N/A	Clear Space to XWalk (in)	N/A
N/A	Any Obstructions?	N/A	N/A	Storm Grate/Utility Hazard?	N/A
	Obstruction Type			Storm Grate/Utility Type	
		N/A			N/A
			Yes	Surface Condition? (G/P)	Good
			No	Curb Slope (%)	13.6

**Remove & Replace Curb Ramp With Two New Directional Ramps or Equivalent.**

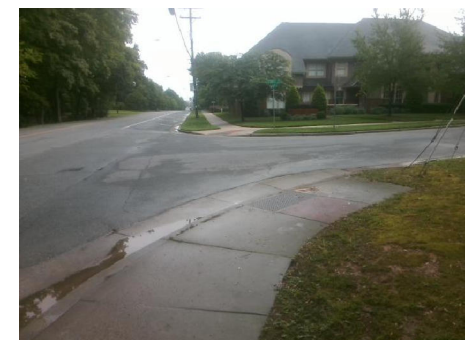
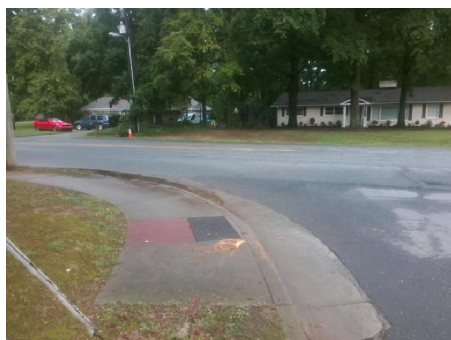
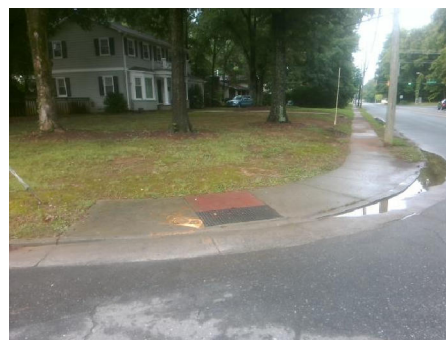
Street 1 Name **STOKES AV**  
 Stop Condition-Street 1 **StopSign**  
 Street 2 Name **PARK SOUTH DR**  
 Stop Condition-Street 2 **None**
