Access Compliance Report

Public Rights-of-Way

(Curb Ramps)

Intersection ID: 43644	Main Street: CEDAR_CROSSINGS_DR	Cross Street: KENDRICK_CROSS_RD	Location: NE
ADA ID: 45CD094A87D1	Ramp Type: PerpDiag	Initial Pass/Fail: Fail	Overall Compliance: No
Severity Score: 10			
Codes/Mitigation Info/Possible Solution		Field Measurements/Component Compliance

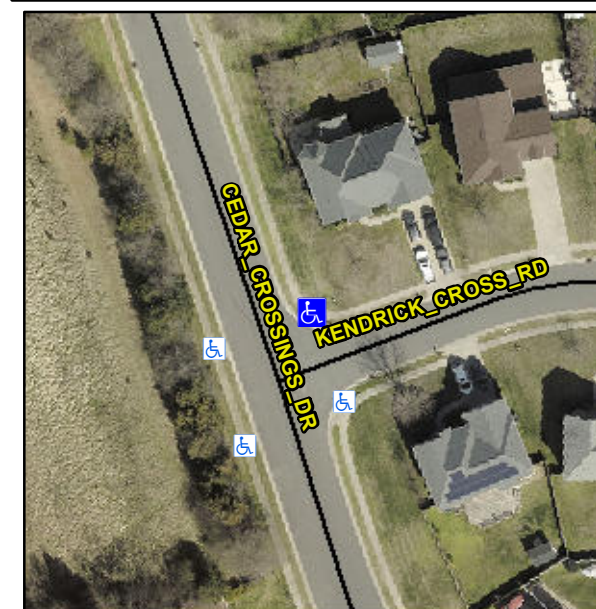
Not Found, R304.5.1, R304.5.3

Compliance	Description	Data	Compliance	Description	Data
N/A	Ramp Length (in)	51.0	Yes	Ramp Slope (%)	5.5
No	Ramp Width (in)	44.0	No	Ramp XSlope (%)	3.8
N/A	Flare Type LT	N/A	N/A	Flare Type RT	N/A
N/A	Flare Slope LT (%)	N/A	N/A	Flare Slope RT (%)	N/A
N/A	Flare Traversable LT?	N/A	N/A	Flare Traversable RT?	N/A
N/A	Landing Length (in)	N/A	N/A	DWS Provided?	N/A
N/A	Landing Width (in)	N/A	N/A	DWS Contrast?	N/A
N/A	Landing Slope (%)	N/A	N/A	DWS Length (in)	N/A
N/A	Landing X Slope (%)	N/A	N/A	DWS Full Width?	N/A
N/A	Landing Curb? (Y/N)	N/A	N/A	DWS Offset (in)	N/A
N/A	Shared Landing?	N/A			
N/A	Gutter Ponding?	N/A	N/A	Gutter Slope (%)	N/A
N/A	Gutter Lip Ht (in)	N/A	N/A	Gutter X Slope (%)	N/A
N/A	Painted X Walk1?	No	N/A	Painted X Walk2?	No
	X Walk 1 Direction	To W		X Walk 2 Direction	To S
N/A	X Walk 1 Width (in)	N/A	N/A	X Walk 2 Width (in)	N/A
	X Walk 1 Slope (%)	2.2		X Walk 2 Slope (%)	2.6
	X Walk 1 X Slope (%)	1.5		X Walk 2 X Slope (%)	0.8

N/A	Ramp inside XWalk1?	N/A	N/A	Ramp inside XWalk2?	N/A
	Road Slope (%)	0.2	N/A	Clear Space?	N/A
	Road X Slope (%)	1.7	N/A	Clear Space to XWalk (in)	N/A
N/A	Any Obstructions?	N/A	N/A	Storm Grate/Utility Hazard?	N/A
	Obstruction Type			Storm Grate/Utility Type	
		N/A			N/A
		Yes		Surface Condition? (G/P)	Good

Remove & Replace Curb Ramp With Two New Directional Ramps or Equivalent.

Total Cost: \$ 3200.00
