Access Compliance Report

Public Rights-of-Way

(Curb Ramps)

Intersection ID: 14918	Main Street: KENILWORTH_AV	Cross Street: PIERCE_ST	Location: S
ADA ID: 45CD385DBD86	Ramp Type: Perp	Initial Pass/Fail: Fail	Overall Compliance: No
		Severity Score: 12.5

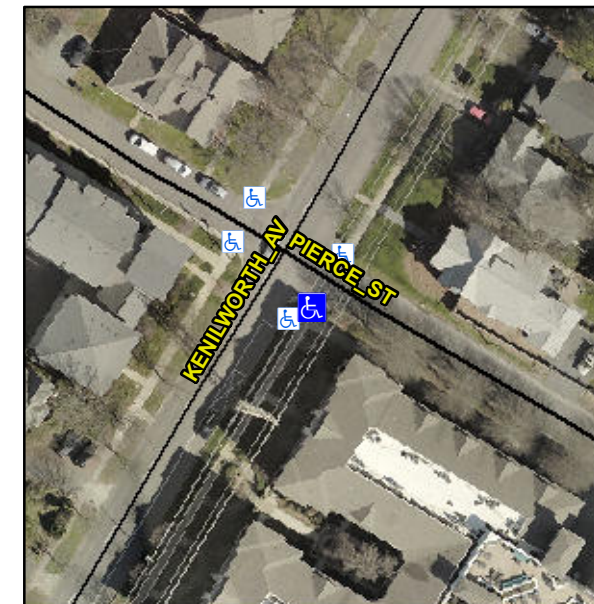
R304.2.2

Compliance	Description	Data	Compliance	Description	Data
N/A	Ramp Length (in)	120.0	No	Ramp Slope (%)	9.0
Yes	Ramp Width (in)	48.0	Yes	Ramp XSlope (%)	1.9
N/A	Flare Type LT	N/A	N/A	Flare Type RT	N/A
N/A	Flare Slope LT (%)	N/A	N/A	Flare Slope RT (%)	N/A
N/A	Flare Traversable LT?	N/A	N/A	Flare Traversable RT?	N/A
N/A	Landing Length (in)	N/A	N/A	DWS Provided?	N/A
N/A	Landing Width (in)	N/A	N/A	DWS Contrast?	N/A
N/A	Landing Slope (%)	N/A	N/A	DWS Length (in)	N/A
N/A	Landing X Slope (%)	N/A	N/A	DWS Full Width?	N/A
N/A	Landing Curb? (Y/N)	N/A	N/A	DWS Offset (in)	N/A
N/A	Shared Landing?	N/A			
N/A	Gutter Ponding?	N/A	N/A	Gutter Slope (%)	N/A
N/A	Gutter Lip Ht (in)	1.0	N/A	Gutter X Slope (%)	N/A
N/A	Painted X Walk1?	No	N/A	Painted X Walk2?	N/A
	X Walk 1 Direction	To NE		X Walk 2 Direction	N/A
N/A	X Walk 1 Width (in)	N/A	N/A	X Walk 2 Width (in)	N/A
	X Walk 1 Slope (%)	0.1		X Walk 2 Slope (%)	N/A
	X Walk 1 X Slope (%)	0.2		X Walk 2 X Slope (%)	N/A

N/A	Ramp inside XWalk1?	N/A	N/A	Ramp inside XWalk2?	N/A
	Road Slope (%)	N/A	N/A	Clear Space?	N/A
	Road X Slope (%)	N/A	N/A	Clear Space to XWalk (in)	N/A
N/A	Any Obstructions?	N/A	N/A	Storm Grate/Utility Hazard?	N/A
	Obstruction Type			Storm Grate/Utility Type	
		N/A			N/A
			Yes	Surface Condition? (G/P)	Good

Possible Solutions:

Remove & Replace Entire Ramp.

Total Cost:

\$ 1850.00
