Access Compliance Report

Public Rights-of-Way

(Curb Ramps)

Intersection ID: 13553	Main Street: WINGATE_AV	Cross Street: DODGE_AV	Location: SE
ADA ID: 45CE63DBF809	Ramp Type: PerpDiag	Initial Pass/Fail: Fail	Overall Compliance: No
Severity Score: 12.5			
Codes/Mitigation Info/Possible Solution		Field Measurements/Component Compliance

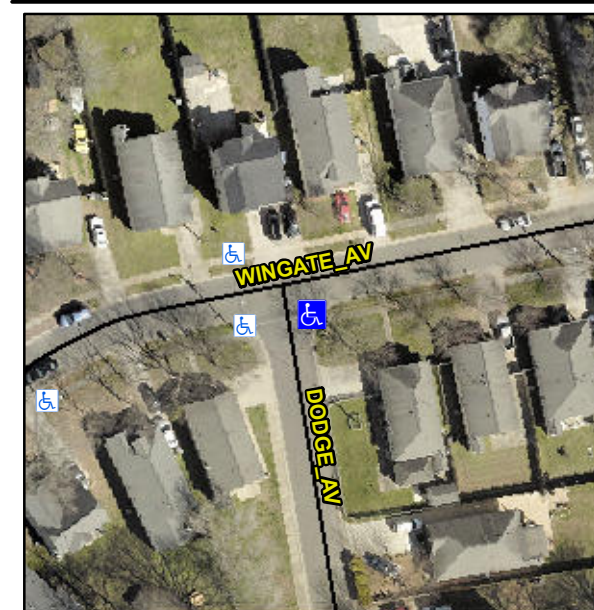
Compliance	Description	Data	Compliance	Description	Data
N/A	Ramp Length (in)	44.0	No	Ramp Slope (%)	8.9
Yes	Ramp Width (in)	48.0	Yes	Ramp XSlope (%)	1.3
N/A	Flare Type LT	N/A	N/A	Flare Type RT	N/A
N/A	Flare Slope LT (%)	N/A	N/A	Flare Slope RT (%)	N/A
N/A	Flare Traversable LT?	N/A	N/A	Flare Traversable RT?	N/A
N/A	Landing Length (in)	N/A	N/A	DWS Provided?	N/A
N/A	Landing Width (in)	N/A	N/A	DWS Contrast?	N/A
N/A	Landing Slope (%)	N/A	N/A	DWS Length (in)	N/A
N/A	Landing X Slope (%)	N/A	N/A	DWS Full Width?	N/A
N/A	Landing Curb? (Y/N)	N/A	N/A	DWS Offset (in)	N/A
N/A	Shared Landing?	N/A			
N/A	Gutter Ponding?	N/A	N/A	Gutter Slope (%)	N/A
N/A	Gutter Lip Ht (in)	N/A	N/A	Gutter X Slope (%)	N/A
N/A	Painted X Walk1?	No	N/A	Painted X Walk2?	No
	X Walk 1 Direction	To N		X Walk 2 Direction	To W
N/A	X Walk 1 Width (in)	N/A	N/A	X Walk 2 Width (in)	N/A
	X Walk 1 Slope (%)	4.3		X Walk 2 Slope (%)	1.6
	X Walk 1 X Slope (%)	1.7		X Walk 2 X Slope (%)	1.5

N/A	Ramp inside XWalk1?	N/A	N/A	Ramp inside XWalk2?	N/A
	Road Slope (%)	0.6	N/A	Clear Space?	N/A
	Road X Slope (%)	3.5	N/A	Clear Space to XWalk (in)	N/A
N/A	Any Obstructions?	N/A	N/A	Storm Grate/Utility Hazard?	N/A
	Obstruction Type			Storm Grate/Utility Type	
		N/A			N/A
			Yes	Surface Condition? (G/P)	Good

Possible Solutions:

Remove & Replace Curb Ramp With Two New Directional Ramps or Equivalent.

Not Found, R304.2.2

Total Cost: \$ 3200.00
