Access Compliance Report

Public Rights-of-Way

(Curb Ramps)

Intersection ID: 11841	Main Street: E_18TH_ST	Cross Street: HARRILL_ST	Location: E
ADA ID: 45CEC4F3FFAB	Ramp Type: Directional1	Initial Pass/Fail: Fail	Overall Compliance: No
			Severity Score: 13.75

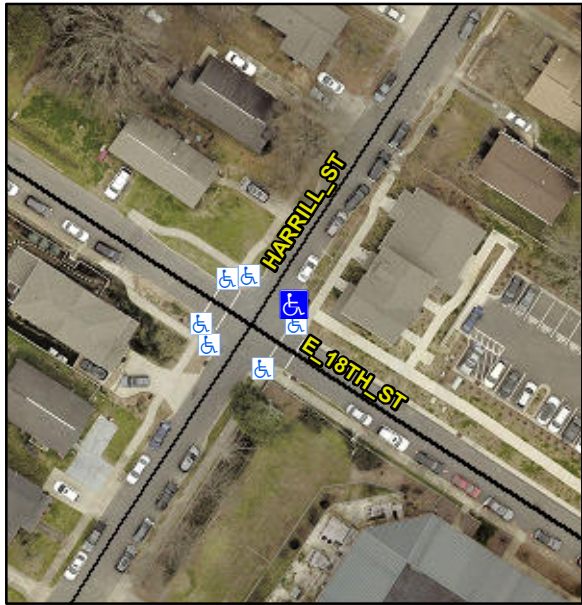
Possible Solutions:						
	Remove & Replace Entire Ramp.						
	Surveyor Notes:						
	N/A						
	PROW/ADA:						
	R304.2.2, R304.5.3						
	Street 1 Name	HARRILL ST					
	Stop Condition-Street 1	None					
	Street 2 Name	N/A					
	Stop Condition-Street 2	N/A					
Total Cost:		\$	1600.00				
		Compliance	Description	Data	Compliance	Description	Data
		N/A	Ramp Length (in)	73.0	N/A	Grade Break?	N/A
		Yes	Ramp Width (in)	57.5	N/A	Grade Break Slope (%)	0.0
		No	Ramp Slope (%)	8.6	N/A	Grade Break XSlope (%)	0.0
		No	Ramp XSlope (%)	2.2			
		N/A	Flare Type LT	N/A	N/A	Flare Type RT	N/A
		N/A	Flare Slope LT (%)	N/A	N/A	Flare Slope RT (%)	0.0
		N/A	Flare Traversable LT?	N/A	N/A	Flare Traversable RT?	N/A
		N/A	Landing Length (in)	0.0	N/A	DWS Provided?	N/A
		N/A	Landing Width (in)	0.0	N/A	DWS Contrast?	N/A
		N/A	Landing Slope (%)	0.0	N/A	DWS Length (in)	N/A

N/A	Landing X Slope (%)	0.0	N/A	DWS Full Width?	N/A
		N/A	Landing Curb? (Y/N)	N/A	N/A	DWS Offset LT (in)	N/A
		N/A	Shared Landing?	N/A	N/A	DWS Offset RT (in)	N/A
		N/A	Gutter Ponding?	Yes	N/A	Gutter Slope (%)	N/A
		N/A	Gutter Lip Ht (in)	0.0	N/A	Gutter X Slope (%)	N/A
		N/A	Painted X Walk1?	No		Road Slope (%)	3.5
			X Walk 1 Direction	To NW		Road X Slope (%)	1.4
			X Walk 1 Width (in)	N/A		Clear Space?	N/A
			X Walk 1 Slope (%)	3.5	N/A	Clear Space to XWalk (in)	N/A
			X Walk 1 X Slope (%)	1.4	N/A	Storm Grate/Utility Hazard?	N/A
		N/A	Ramp inside XWalk1?	N/A		Storm Grate/Utility Type	
		N/A	Any Obstructions?	N/A			N/A
			Obstruction Type		Yes	Surface Condition? (G/P)	Good
				N/A	N/A	Curb Slope (%)	11.3
