Access Compliance Report

Public Rights-of-Way

(Curb Ramps)

Intersection ID: 16080	Main Street: BUENA_VISTA_AV	Cross Street: LANIER_AV	Location: SW
ADA ID: 45D018DA5652	Ramp Type: Directional1	Initial Pass/Fail: Fail	Overall Compliance: No
		Severity Score: 30

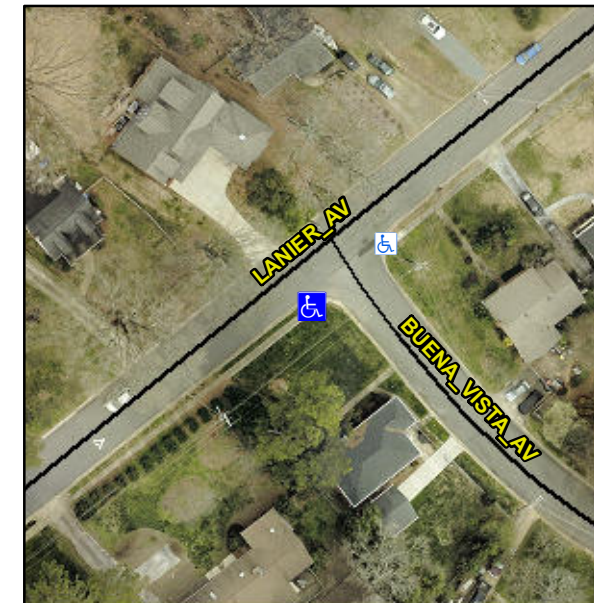
Compliance	Description	Data	Compliance	Description	Data
N/A	Ramp Length (in)	79.0	N/A	Grade Break?	N/A
No	Ramp Width (in)	35.0	N/A	Grade Break Slope (%)	0.0
Yes	Ramp Slope (%)	6.7	N/A	Grade Break XSlope (%)	0.0
No	Ramp XSlope (%)	5.7			
N/A	Flare Type LT	N/A	N/A	Flare Type RT	N/A
N/A	Flare Slope LT (%)	N/A	N/A	Flare Slope RT (%)	0.0
N/A	Flare Traversable LT?	N/A	N/A	Flare Traversable RT?	N/A
N/A	Landing Length (in)	0.0	N/A	DWS Provided?	N/A
N/A	Landing Width (in)	0.0	N/A	DWS Contrast?	N/A
N/A	Landing Slope (%)	0.0	N/A	DWS Length (in)	N/A
N/A	Landing X Slope (%)	0.0	N/A	DWS Full Width?	N/A
N/A	Landing Curb? (Y/N)	N/A	N/A	DWS Offset LT (in)	N/A
N/A	Shared Landing?	N/A	N/A	DWS Offset RT (in)	N/A
N/A	Gutter Ponding?	0.0	N/A	Gutter Slope (%)	N/A
N/A	Gutter Lip Ht (in)	0.0	N/A	Gutter X Slope (%)	N/A
N/A	Painted X Walk1?	No		Road Slope (%)	2.2
	X Walk 1 Direction	To NE		Road X Slope (%)	2.7
	X Walk 1 Width (in)	N/A		Clear Space?	N/A

X Walk 1 Slope (%)	2.2	N/A	Clear Space to XWalk (in)	N/A
	X Walk 1 X Slope (%)	2.7	N/A	Storm Grate/Utility Hazard?	N/A
N/A	Ramp inside XWalk1?	N/A		Storm Grate/Utility Type	
N/A	Any Obstructions?	N/A			N/A
	Obstruction Type		Yes	Surface Condition? (G/P)	Good
			N/A	Curb Slope (%)	12.6

Possible Solutions:

Remove & Replace Entire Ramp.

R304.5.1, R304.5.3
