Access Compliance Report

Public Rights-of-Way

(Curb Ramps)

Intersection ID: 19931	Main Street: CARNEGIE BV	Cross Street: ASSEMBLY ST	Location: NE
ADA ID: 45DFF1DEEAA8	Ramp Type: Perp	Initial Pass/Fail: Fail	Overall Compliance: No
		Severity Score: 10

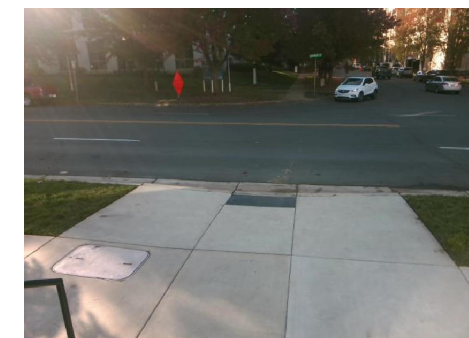
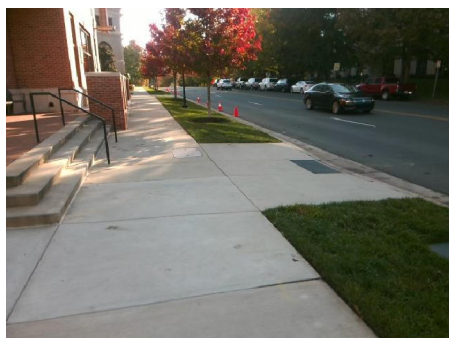
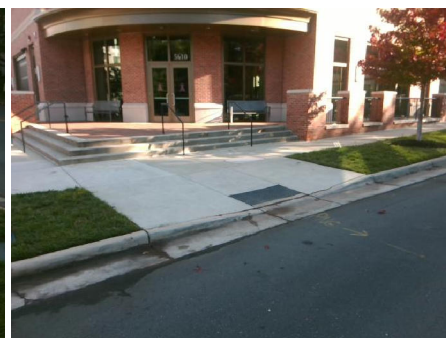
Not Found, R304.5.1, R304.5.3

Compliance	Description	Data	Compliance	Description	Data
N/A	Ramp Length (in)	97.0	Yes	Ramp Slope (%)	8.3
No	Ramp Width (in)	47.0	No	Ramp XSlope (%)	2.8
N/A	Flare Type LT	N/A	N/A	Flare Type RT	N/A
N/A	Flare Slope LT (%)	N/A	N/A	Flare Slope RT (%)	N/A
N/A	Flare Traversable LT?	N/A	N/A	Flare Traversable RT?	N/A
N/A	Landing Length (in)	N/A	N/A	DWS Provided?	N/A
N/A	Landing Width (in)	N/A	N/A	DWS Contrast?	N/A
N/A	Landing Slope (%)	N/A	N/A	DWS Length (in)	N/A
N/A	Landing X Slope (%)	N/A	N/A	DWS Full Width?	N/A
N/A	Landing Curb? (Y/N)	N/A	N/A	DWS Offset (in)	N/A
N/A	Shared Landing?	N/A			
N/A	Gutter Ponding?	N/A	N/A	Gutter Slope (%)	N/A
N/A	Gutter Lip Ht (in)	N/A	N/A	Gutter X Slope (%)	N/A
N/A	Painted X Walk1?	No	N/A	Painted X Walk2?	N/A
	X Walk 1 Direction	To S		X Walk 2 Direction	N/A
N/A	X Walk 1 Width (in)	N/A	N/A	X Walk 2 Width (in)	N/A
	X Walk 1 Slope (%)	2.6		X Walk 2 Slope (%)	N/A
	X Walk 1 X Slope (%)	1.2		X Walk 2 X Slope (%)	N/A

Remove & Replace Entire Ramp.
