Access Compliance Report

Public Rights-of-Way

(Curb Ramps)

Intersection ID: 42513	Main Street: ELM_LN	Cross Street: INDIGO_RW	Location:	N
ADA ID: 45E18403B1CD	Ramp Type: Perp	Initial Pass/Fail: Fail	Overall Compliance: No	Severity Score: 25
Codes/Mitigation Info/Possible Solution		Field Measurements/Component Compliance

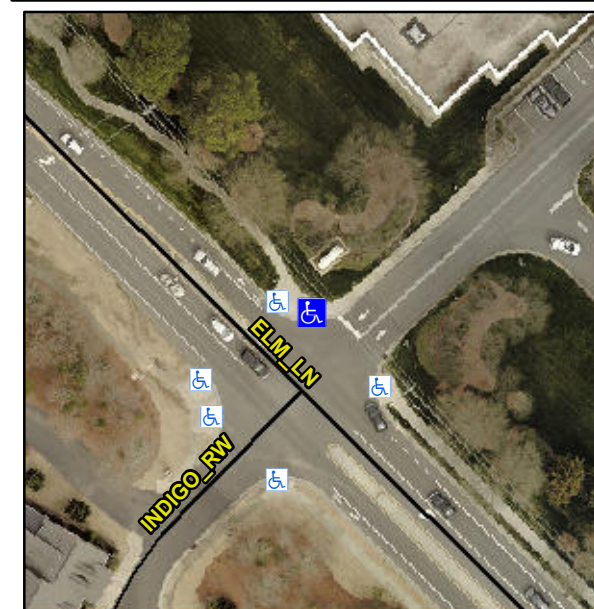
Compliance	Description	Data	Compliance	Description	Data
N/A	Ramp Length (in)	95.0	Yes	Ramp Slope (%)	5.5
Yes	Ramp Width (in)	48.0	No	Ramp XSlope (%)	7.5
N/A	Flare Type LT	N/A	N/A	Flare Type RT	N/A
N/A	Flare Slope LT (%)	N/A	N/A	Flare Slope RT (%)	N/A
N/A	Flare Traversable LT?	N/A	N/A	Flare Traversable RT?	N/A
N/A	Landing Length (in)	N/A	N/A	DWS Provided?	N/A
N/A	Landing Width (in)	N/A	N/A	DWS Contrast?	N/A
N/A	Landing Slope (%)	N/A	N/A	DWS Length (in)	N/A
N/A	Landing X Slope (%)	N/A	N/A	DWS Full Width?	N/A
N/A	Landing Curb? (Y/N)	N/A	N/A	DWS Offset (in)	N/A
N/A	Shared Landing?	N/A			
N/A	Gutter Ponding?	N/A	N/A	Gutter Slope (%)	N/A
N/A	Gutter Lip Ht (in)	N/A	N/A	Gutter X Slope (%)	N/A
N/A	Painted X Walk1?	No	N/A	Painted X Walk2?	N/A
	X Walk 1 Direction	To SE		X Walk 2 Direction	N/A
N/A	X Walk 1 Width (in)	N/A	N/A	X Walk 2 Width (in)	N/A
	X Walk 1 Slope (%)	1.9		X Walk 2 Slope (%)	N/A
	X Walk 1 X Slope (%)	3.9		X Walk 2 X Slope (%)	N/A

N/A	Ramp inside XWalk1?	N/A	N/A	Ramp inside XWalk2?	N/A
	Road Slope (%)	N/A	N/A	Clear Space?	N/A
	Road X Slope (%)	N/A	N/A	Clear Space to XWalk (in)	N/A
N/A	Any Obstructions?	N/A	N/A	Storm Grate/Utility Hazard?	N/A
	Obstruction Type			Storm Grate/Utility Type	
		N/A			N/A
			Yes	Surface Condition? (G/P)	Good

Possible Solutions:

Remove & Replace Entire Ramp.

PROW/ADA:

R304.5.3
