Access Compliance Report

Public Rights-of-Way (Curb Ramps)

Intersection ID: 27315	Main Street: ELM_LN	Cross Street: BALLANTYNE_TRACE_CT	Location: W
ADA ID: 45F355C1804B	Ramp Type: PerpDiag	Initial Pass/Fail: Fail	Overall Compliance: No
Severity Score: 22.5			
Codes/Mitigation Info/Possible Solution		Field Measurements/Component Compliance

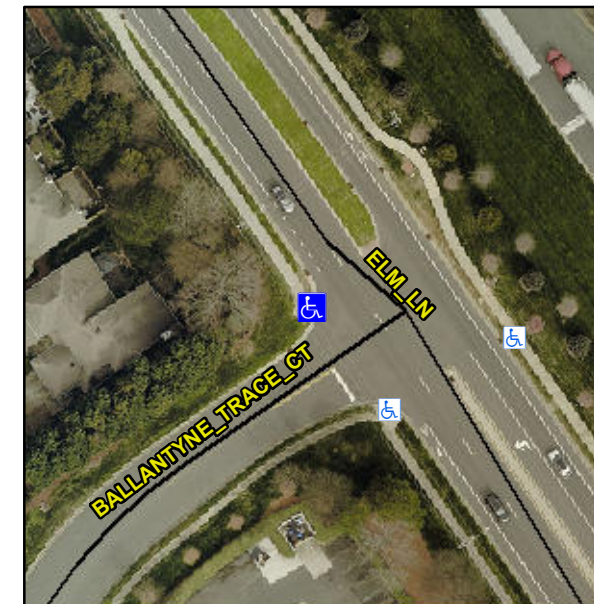
Not Found, R304.5.1, R304.2.2, R304.5.3

Compliance	Description	Data	Compliance	Description	Data
N/A	Ramp Length (in)	47.5	No	Ramp Slope (%)	9.1
No	Ramp Width (in)	46.5	No	Ramp XSlope (%)	4.1
N/A	Flare Type LT	N/A	N/A	Flare Type RT	N/A
N/A	Flare Slope LT (%)	N/A	N/A	Flare Slope RT (%)	N/A
N/A	Flare Traversable LT?	N/A	N/A	Flare Traversable RT?	N/A
N/A	Landing Length (in)	N/A	N/A	DWS Provided?	N/A
N/A	Landing Width (in)	N/A	N/A	DWS Contrast?	N/A
N/A	Landing Slope (%)	N/A	N/A	DWS Length (in)	N/A
N/A	Landing X Slope (%)	N/A	N/A	DWS Full Width?	N/A
N/A	Landing Curb? (Y/N)	N/A	N/A	DWS Offset (in)	N/A
N/A	Shared Landing?	N/A			
N/A	Gutter Ponding?	N/A	N/A	Gutter Slope (%)	N/A
N/A	Gutter Lip Ht (in)	N/A	N/A	Gutter X Slope (%)	N/A
N/A	Painted X Walk1?	No	N/A	Painted X Walk2?	No
	X Walk 1 Direction	To SE		X Walk 2 Direction	To NE
N/A	X Walk 1 Width (in)	N/A	N/A	X Walk 2 Width (in)	N/A
	X Walk 1 Slope (%)	0.4		X Walk 2 Slope (%)	8.0
	X Walk 1 X Slope (%)	6.2		X Walk 2 X Slope (%)	0.7

N/A	Ramp inside XWalk1?	N/A	N/A	Ramp inside XWalk2?	N/A
	Road Slope (%)	1.1	N/A	Clear Space?	N/A
	Road X Slope (%)	6.0	N/A	Clear Space to XWalk (in)	N/A
N/A	Any Obstructions?	N/A	N/A	Storm Grate/Utility Hazard?	N/A
	Obstruction Type			Storm Grate/Utility Type	
		N/A			N/A
			Yes	Surface Condition? (G/P)	Good

Possible Solutions:

Remove & Replace Curb Ramp With Two New Directional Ramps or Equivalent.
