Access Compliance Report

Public Rights-of-Way

(Curb Ramps)

Intersection ID: N/A	Main Street: TUCKASEEGEE_RD	Cross Street: N/A	Location: N
ADA ID: 4610053C4765	Ramp Type: Perp	Initial Pass/Fail: Fail	Overall Compliance: No
Severity Score: 22.5			
Codes/Mitigation Info/Possible Solution		Field Measurements/Component Compliance

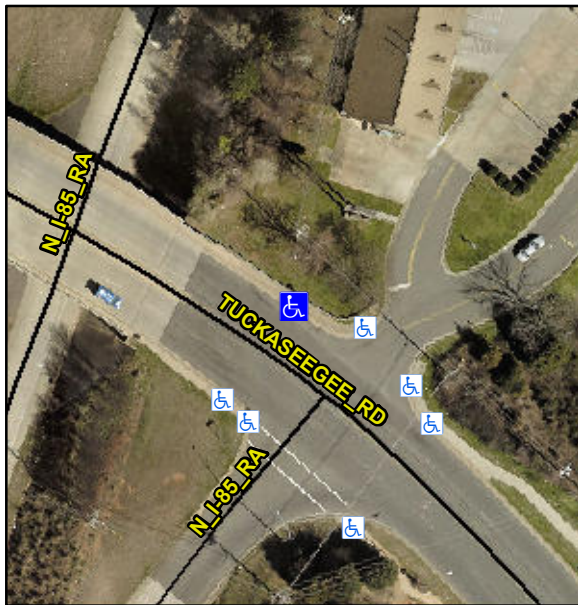
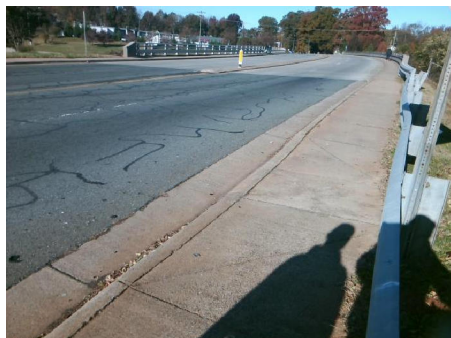
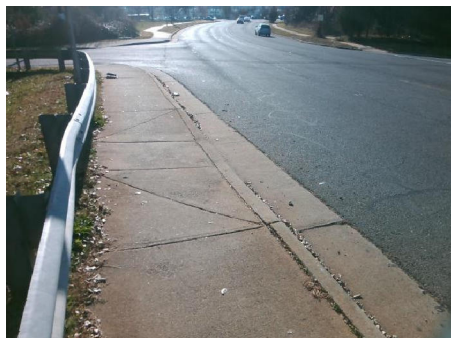
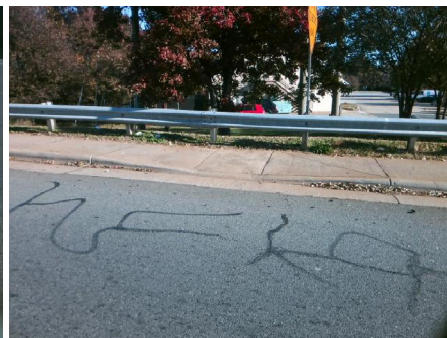
Not Found, R304.5.1, R304.2.2, R304.5.3

Compliance	Description	Data	Compliance	Description	Data
N/A	Ramp Length (in)	60.0	No	Ramp Slope (%)	8.7
No	Ramp Width (in)	44.0	No	Ramp XSlope (%)	4.1
N/A	Flare Type LT	N/A	N/A	Flare Type RT	N/A
N/A	Flare Slope LT (%)	N/A	N/A	Flare Slope RT (%)	N/A
N/A	Flare Traversable LT?	No	N/A	Flare Traversable RT?	No
N/A	Landing Length (in)	N/A	N/A	DWS Provided?	N/A
N/A	Landing Width (in)	N/A	N/A	DWS Contrast?	N/A
N/A	Landing Slope (%)	N/A	N/A	DWS Length (in)	N/A
N/A	Landing X Slope (%)	N/A	N/A	DWS Full Width?	N/A
N/A	Landing Curb? (Y/N)	N/A	N/A	DWS Offset (in)	N/A
N/A	Shared Landing?	N/A			
N/A	Gutter Ponding?	N/A	N/A	Gutter Slope (%)	N/A
N/A	Gutter Lip Ht (in)	N/A	N/A	Gutter X Slope (%)	N/A
N/A	Painted X Walk1?	No	N/A	Painted X Walk2?	N/A
	X Walk 1 Direction	To SW		X Walk 2 Direction	N/A
N/A	X Walk 1 Width (in)	N/A	N/A	X Walk 2 Width (in)	N/A
	X Walk 1 Slope (%)	2.1		X Walk 2 Slope (%)	N/A
	X Walk 1 X Slope (%)	3.0		X Walk 2 X Slope (%)	N/A

N/A	Ramp inside XWalk1?	N/A	N/A	Ramp inside XWalk2?	N/A
	Road Slope (%)	N/A	N/A	Clear Space?	N/A
	Road X Slope (%)	N/A	N/A	Clear Space to XWalk (in)	N/A
N/A	Any Obstructions?	N/A	N/A	Storm Grate/Utility Hazard?	N/A
	Obstruction Type			Storm Grate/Utility Type	
		N/A			N/A
			Yes	Surface Condition? (G/P)	Good

Remove & Replace Entire Ramp.
