Access Compliance Report

Public Rights-of-Way

(Curb Ramps)

Intersection ID: 14806		Main Street: HENLEY_PL		Cross Street: QUEENS_RD		Location: N											
ADA ID: 46246BAC92CA		Ramp Type: Directional1		Initial Pass/Fail: Fail		Overall Compliance: No		Severity Score: 25									
Codes/Mitigation Info/Possible Solution				Field Measurements/Component Compliance													
<div>

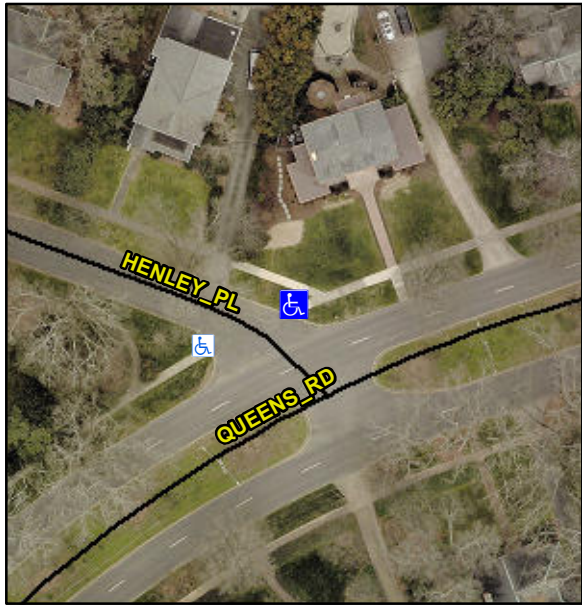
</div> <div>Street 1 Name<div>HENLEY_PL</div></div> <div>Stop Condition-Street 1<div>StopSign</div></div> <div>Street 2 Name<div>N/A</div></div> <div>Stop Condition-Street 2<div>N/A</div></div> <div>Possible Solutions:<div>Remove & Replace Entire Ramp.</div></div> <div>Surveyor Notes:<div>N/A</div></div> <div>PROW/ADA:<div>R304.5.3</div></div> <div>Total Cost:<div>\$1600.00</div></div>				Compliance		Description		Data		Compliance		Description		Data			
				N/A		Ramp Length (in)		71.0		N/A		Grade Break?		N/A			
				Yes		Ramp Width (in)		48.0		N/A		Grade Break Slope (%)		0.0			
				Yes		Ramp Slope (%)		6.3		N/A		Grade Break XSlope (%)		0.0

No		Ramp XSlope (%)		9.7									
				N/A		Flare Type LT		N/A		N/A		Flare Type RT		N/A			
				N/A		Flare Slope LT (%)		N/A		N/A		Flare Slope RT (%)		0.0			
				N/A		Flare Traversable LT?		N/A		N/A		Flare Traversable RT?		N/A			
				N/A		Landing Length (in)		0.0		N/A		DWS Provided?		N/A			
				N/A		Landing Width (in)		0.0		N/A		DWS Contrast?		N/A			
				N/A		Landing Slope (%)		0.0		N/A		DWS Length (in)		N/A			
				N/A		Landing X Slope (%)		0.0		N/A		DWS Full Width?		N/A			
				N/A		Landing Curb? (Y/N)		N/A		N/A		DWS Offset LT (in)		N/A			
				N/A		Shared Landing?		N/A		N/A		DWS Offset RT (in)		N/A			
				N/A		Gutter Ponding?		0.0		N/A		Gutter Slope (%)		N/A			
				N/A		Gutter Lip Ht (in)		0.0		N/A		Gutter X Slope (%)		N/A			
				N/A		Painted X Walk1?		No				Road Slope (%)		2.6			
						X Walk 1 Direction		To SW				Road X Slope (%)		0.4			
						X Walk 1 Width (in)		N/A				Clear Space?		N/A			
						X Walk 1 Slope (%)		2.6		N/A		Clear Space to XWalk (in)		N/A

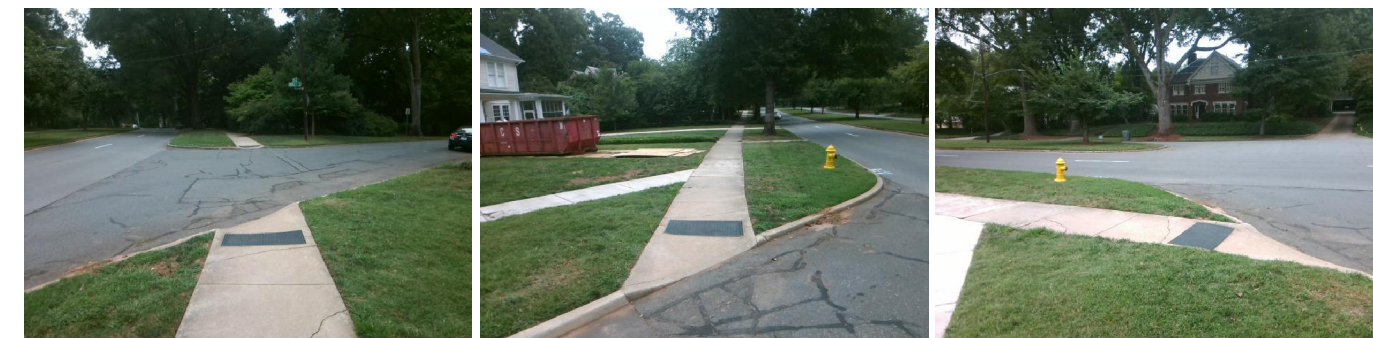
X Walk 1 X Slope (%)		0.4		N/A		Storm Grate/Utility Hazard?		N/A			
				N/A		Ramp inside XWalk1?		N/A				Storm Grate/Utility Type					
				N/A		Any Obstructions?		N/A						N/A			
						Obstruction Type				Yes		Surface Condition? (G/P)		Good			
										N/A		N/A		Curb Slope (%)		4.5
