## Access Compliance Report Public Rights-of-Way (Curb Ramps)

Intersection ID: 15310 Main Street: PIERSON\_DR Cross Street: WOODHILL\_LN Location: E

ADA ID: 4651799E02D6 Ramp Type: BlendTrans1 Initial Pass/Fail: Fail Overall Compliance: No Severity Score: 21.25

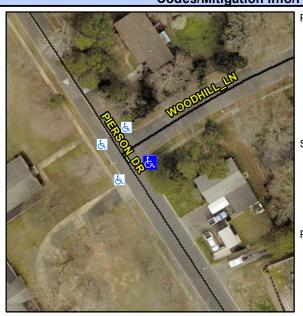
Not Found, R304.5.1, R304.5.3

Compliance         Description           N/A         Ramp Length (in)           31.0         Yes           BlendTrans Slope (%)	<u>Data</u> 0.3
	0.3
No Ramp Width (in) 40.0 No BlendTrans XSlope (%)	6.8
N/A Flare Type LT N/A N/A Flare Type RT	N/A
N/A Flare Slope LT (%) N/A N/A Flare Slope RT (%)	N/A
N/A Flare Traversable LT? N/A N/A Flare Traversable RT?	N/A
N/A Landing Length (in) N/A N/A DWS Provided?	N/A
N/A Landing Width (in) N/A N/A DWS Contrast?	N/A
N/A Landing Slope (%) N/A N/A DWS Length (in)	N/A
N/A Landing X Slope (%) N/A N/A DWS Full Width?	N/A
N/A Landing Curb? (Y/N) N/A N/A DWS Offset (in)	N/A
N/A Shared Landing? N/A	
N/A Gutter Ponding? N/A N/A Gutter Slope (%)	N/A
N/A Gutter Lip Ht (in) N/A N/A Gutter X Slope (%)	N/A
N/A Painted X Walk1? No N/A Painted X Walk2?	No
X Walk 1 Direction To NW X Walk 2 Direction	To SW
X Walk 1 Width (in) N/A X Walk 2 Width (in)	N/A
X Walk 1 Slope (%) 1.5 X Walk 2 Slope (%)	7.4

X Walk 1 X Slope (%) 7.0 X Walk 2 X Slope (%)	1.2
N/A Ramp inside XWalk1? N/A N/A Ramp inside XWalk2?	N/A
Road Slope (%) 5.3 Clear Space?	N/A
Road X Slope (%) 5.6 N/A Clear Space to XWalk (i	n) <b>N/A</b>
N/A Any Obstructions? N/A N/A Storm Grate/Utility Haza	rd? <b>N/A</b>
Obstruction Type Storm Grate/Utility Type	
N/A	N/A
Yes Surface Condition? (G/F	) Good
No Curb Slope (%)	9.5
and clope (%)	0.0

WOODHILL LN StopSign PIERSON DR None Possible Solutions:

Remove & Replace Curb Ramp With Two New Directional Ramps or Equivalent.
