## **Access Compliance Report Public Rights-of-Way** (Curb Ramps)

Intersection ID: 20510 Main Street: FAIRVIEW\_RD Cross Street: ARBOR\_WAY Location: SW **ADA ID: 465CDA5A337E Overall Compliance: No** Ramp Type: Perp Initial Pass/Fail: Fail **Severity Score:** 22.5

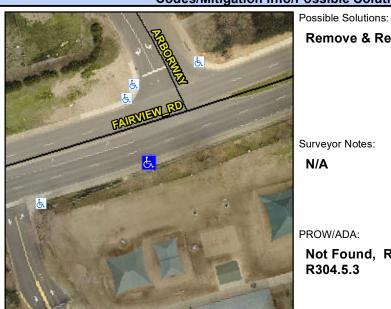
Field Measurements/Component Compliance								
Comp	liance Description	Data	Comp	liance	Description	Data		
N/A	Ramp Length (in)	38.0	No	Ramp	Slope (%)	8.4		
No	Ramp Width (in)	43.0	No	Ramp	XSlope (%)	4.8		
N/A	Flare Type LT	N/A	N/A Flare Type RT		N/A			
N/A	Flare Slope LT (%)	N/A	N/A Flare Slope RT (%)		N/A			
N/A	Flare Traversable LT?	N/A	N/A Flare Traversable RT?		N/A			
N/A	Landing Length (in)	N/A	N/A	DWS	Provided?	N/A		
N/A	Landing Width (in)	N/A	N/A	DWS	Contrast?	N/A		
N/A	Landing Slope (%)	N/A	N/A	DWS	Length (in)	N/A		
N/A	Landing X Slope (%)	N/A	N/A	DWS	Full Width?	N/A		
N/A	Landing Curb? (Y/N)	N/A	N/A	DWS	Offset (in)	N/A		
N/A	Shared Landing?	N/A						
N/A	Gutter Ponding?	N/A	N/A	Gutte	r Slope (%)	N/A		
N/A	Gutter Lip Ht (in)	N/A	N/A	Gutte	r X Slope (%)	N/A		
N/A	Painted X Walk1?	No	N/A	Painte	ed X Walk2?	N/A		
	X Walk 1 Direction	To N		X Wa	lk 2 Direction	N/A		
N/A	X Walk 1 Width (in)	N/A	N/A	X Wa	lk 2 Width (in)	N/A

X Walk 1 Slope (%)	1.3		X Wa	lk 2 Slope (%)	N/A		
	X Walk 1 X Slope (%)	3.6		X Wa	lk 2 X Slope (%)	N/A		
N/A	Ramp inside XWalk1?	N/A	N/A	Ramp	inside XWalk2?	N/A		
	Road Slope (%)	N/A	N/A	Clear	Space?	N/A		
	Road X Slope (%)	N/A	N/A	Clear	Space to XWalk (in)	N/A		
N/A	Any Obstructions?	N/A	N/A	Storm	n Grate/Utility Hazard?	N/A		
	Obstruction Type			Storm	Grate/Utility Type			
		N/A				N/A		
			Yes	Surfa	ce Condition? (G/P)	Good

Remove & Replace Entire Ramp.						
Surveyor Notes:						
N/A						
PROW/ADA:						
Not Found, R304.5.1, R304.2.2, R304.5.3

Total Cost:	\$ 1850.00
