Access Compliance Report Public Rights-of-Way (Curb Ramps)

-								
Intersection ID: 44473	Main St	Main Street: AMES_HOLLOW_RD			COREY_COMMON_AV	Location:	NW			
ADA ID: 465EE7C5A336	Ramp T	Ramp Type: PerpDiag			il: Fail Overall C	o Severity Score:	8.75			
Codes/Mitigation Info/Possible Solution				Field Measurements/Component Compliance						
		Possible Solutions:	C	Compliance Description		Data Compliance Description			Data	
		Remove & Replace Curb Ramp W	/ith N	/A	Ramp Length (in)	48.0	Yes	Ramp Slope (%)	6.5	
		Two New Directional Ramps or	N	0	Ramp Width (in)	40.0	Yes	Ramp XSlope (%)	1.8	
		Equivalent.	Ν	/ A	Flare Type LT	N/A	N/A	Flare Type RT	N/A

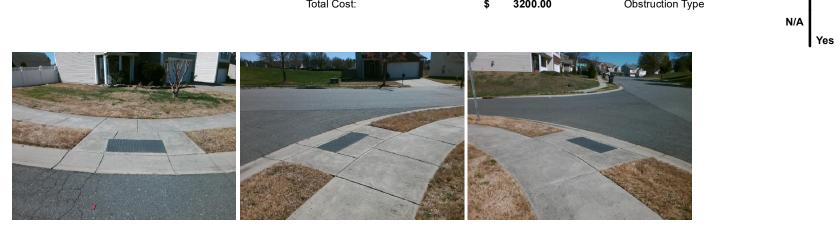
N. C.		N	/ A	Flare Slope LT (%)	N/A	N/A	Flare Slope RT (%)	N/A	
123	1 1/1/1/1/1		N	/ A	Flare Traversable LT?	N/A	N/A	Flare Traversable RT?	N/A	
			N	/ A	Landing Length (in)	N/A	N/A	DWS Provided?	N/A	
	6		N	/ A	Landing Width (in)	N/A	N/A	DWS Contrast?	N/A	
	NOV /	N/A	N	/ A	Landing Slope (%)	N/A	N/A	DWS Length (in)	N/A	
	MOILE &		N	/ A	Landing X Slope (%)	N/A	N/A	DWS Full Width?	N/A	
GOIEL COM &				/ A	Landing Curb? (Y/N)	N/A	N/A	DWS Offset (in)	N/A	
			N	/ A	Shared Landing?	N/A		()		
	PROW/ADA:		/A	Gutter Ponding?	N/A	N/A	Gutter Slope (%)	N/A		
Not Found, R304.5.1				/A	Gutter Lip Ht (in)	N/A	N/A	Gutter X Slope (%)	N/A	
				/A	Painted X Walk1?	No	N/A	Painted X Walk2?	No	
					X Walk 1 Direction	To S		X Walk 2 Direction	To E	
			N	/A	X Walk 1 Width (in)	N/A	N/A	X Walk 2 Width (in)	N/A	
Street 1 Name	COREY COMMON AV	•			X Walk 1 Slope (%)	7.2		X Walk 2 Slope (%)	4.8	
Stop Condition-Street 2	None				X Walk 1 X Slope (%)	2.7		X Walk 2 X Slope (%)	4.2

Street 2 Name	AMES HOLLOW RD		N	/A	Ramp inside XWalk1?	N/A	N/A	Ramp inside XWalk2?	N/A	
Stop Condition-Street 1	StopSign				Road Slope (%)	0.9	N/A	Clear Space?	N/A	
	ctopolyn				Road X Slope (%)	5.1	N/A	Clear Space to XWalk (in)	N/A	
			N	/A	Any Obstructions?	N/A	N/A	Storm Grate/Utility Hazard?	N/A	
		Total Cost: \$ 32	200.00		Obstruction Type			Storm Grate/Utility Type		
						N/A		clothi crato, clinty Typo	N/A	
						IN/A			11/1

s Surface Condition? (G/P) Good
