## **Access Compliance Report Public Rights-of-Way** (Curb Ramps)

Intersection ID: 49383 Main Street: CORRIENTE CT **Cross Street: SOUTH DEVON ST** Location: N ADA ID: 46624A96E206 Ramp Type: Perp Initial Pass/Fail: Fail **Overall Compliance: No Severity Score:** 8.75

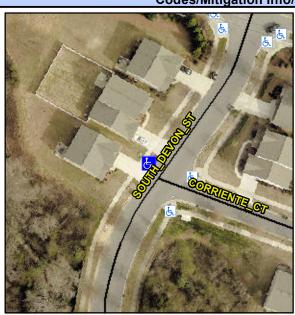
**SOUTH DEVON ST** Street 1 Name Stop Condition-Street 2 None Street 2 Name N/A Stop Condition-Street 1 N/A

Ramp Width (in)	46.5	Yes	Ramp XSlope (%)	0.9
Flare Type LT	N/A	N/A	Flare Type RT	N/A
Flare Slope LT (%)	N/A	N/A	Flare Slope RT (%)	N/A
Flare Traversable LT?	N/A	N/A	Flare Traversable RT?	N/A
Landing Length (in)	N/A	N/A	DWS Provided?	N/A
Landing Width (in)	N/A	N/A	DWS Contrast?	N/A
Landing Slope (%)	N/A	N/A	DWS Length (in)	N/A
Landing X Slope (%)	N/A	N/A	DWS Full Width?	N/A
Landing Curb? (Y/N)	N/A	N/A	DWS Offset (in)	N/A
Shared Landing?	N/A			
Gutter Ponding?	N/A	N/A	Gutter Slope (%)	N/A
Gutter Lip Ht (in)	N/A	N/A	Gutter X Slope (%)	N/A
Painted X Walk1?	No	N/A	Painted X Walk2?	N/A
X Walk 1 Direction	To S		X Walk 2 Direction	N/A
X Walk 1 Width (in)	N/A	N/A	X Walk 2 Width (in)	N/A
X Walk 1 Slope (%)	0.5		X Walk 2 Slope (%)	N/A
X Walk 1 X Slope (%)	0.7		X Walk 2 X Slope (%)	N/A
Ramp inside XWalk1?	N/A	N/A	Ramp inside XWalk2?	N/A
Road Slope (%)	N/A	N/A	Clear Space?	N/A
Road X Slope (%)	N/A	N/A	Clear Space to XWalk (in)	N/A

Any Obstructions?	N/A	N/A	Storm Grate/Utility Hazard?	N/A
Obstruction Type			Storm Grate/Utility Type	
	N/A			N/A
		Yes	Surface Condition? (G/P)	Good

Possible Solutions:	Compli	ance	Description
Remove & Replace Entire Ramp.	N/A	A Ramp Length (in)	
·	No	Ram	o Width (in)
	N/A	Flare	Type LT
	N/A	Flare	Slope LT (%)
	N/A	Flare	Traversable LT
	N/A	Land	ing Length (in)
Surveyor Notes:	N/A	Land	ing Width (in)
N/A	N/A	Land	ing Slope (%)
	N/A	Land	ing X Slope (%)
	N/A	Land	ing Curb? (Y/N)
	N/A	Share	ed Landing?
PROW/ADA:	N/A	Gutte	er Ponding?
Not Found, R304.5.1	N/A	Gutte	er Lip Ht (in)
	N/A	Paint	ed X Walk1?
		X Wa	lk 1 Direction
	N/A	X Wa	lk 1 Width (in)
		X Wa	lk 1 Slope (%)
		X Wa	lk 1 X Slope (%
	N/A	Ram	o inside XWalk1

,		
N/A		N/A
		N/A
		N/A
		N/A
PROW/ADA:		N/A
Not Found, R304.5.1		N/A
·		N/A
		N/A
		N/A
		N/A
Total Cost:	\$ 1850.00
