Intersection ID: 15368	Main Street: KENILWORTH_AV	Cross Street: LATTIMORE_ST	Location:	E
ADA ID: 468862C031E5	Ramp Type: PerpDiag	Initial Pass/Fail: Fail	Overall Compliance: No	Severity Score: 8.75

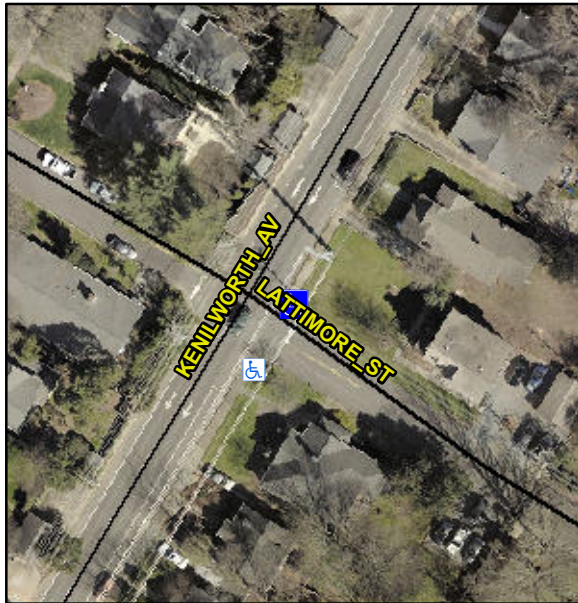
Not Found, R304.5.1

Compliance	Description	Data	Compliance	Description	Data
N/A	Ramp Length (in)	45.0	Yes	Ramp Slope (%)	6.7
No	Ramp Width (in)	40.5	Yes	Ramp XSlope (%)	1.3
N/A	Flare Type LT	N/A	N/A	Flare Type RT	N/A
N/A	Flare Slope LT (%)	N/A	N/A	Flare Slope RT (%)	N/A
N/A	Flare Traversable LT?	N/A	N/A	Flare Traversable RT?	N/A
N/A	Landing Length (in)	N/A	N/A	DWS Provided?	N/A
N/A	Landing Width (in)	N/A	N/A	DWS Contrast?	N/A
N/A	Landing Slope (%)	N/A	N/A	DWS Length (in)	N/A
N/A	Landing X Slope (%)	N/A	N/A	DWS Full Width?	N/A
N/A	Landing Curb? (Y/N)	N/A	N/A	DWS Offset (in)	N/A
N/A	Shared Landing?	N/A			
N/A	Gutter Ponding?	N/A	N/A	Gutter Slope (%)	N/A
N/A	Gutter Lip Ht (in)	N/A	N/A	Gutter X Slope (%)	N/A
N/A	Painted X Walk1?	No	N/A	Painted X Walk2?	No
	X Walk 1 Direction	To NW		X Walk 2 Direction	To SW
N/A	X Walk 1 Width (in)	N/A	N/A	X Walk 2 Width (in)	N/A
	X Walk 1 Slope (%)	1.8		X Walk 2 Slope (%)	0.8
	X Walk 1 X Slope (%)	0.9		X Walk 2 X Slope (%)	2.4

N/A	Ramp inside XWalk1?	N/A	N/A	Ramp inside XWalk2?	N/A
	Road Slope (%)	0.7	N/A	Clear Space?	N/A
	Road X Slope (%)	1.7	N/A	Clear Space to XWalk (in)	N/A
N/A	Any Obstructions?	N/A	N/A	Storm Grate/Utility Hazard?	N/A
	Obstruction Type			Storm Grate/Utility Type	
		N/A			N/A
			Yes	Surface Condition? (G/P)	Good

Remove & Replace Curb Ramp With Two New Directional Ramps or Equivalent.
