Access Compliance Report

Public Rights-of-Way

(Curb Ramps)

Intersection ID: 43347	Main Street: PROSPERITY RIDGE RD	Cross Street: PROSPERITY CHURCH RD	Location: NE
ADA ID: 4690D908ABAD	Ramp Type: Perp	Initial Pass/Fail: Fail	Overall Compliance: No
Codes/Mitigation Info/Possible Solution		Field Measurements/Component Compliance	
Severity Score: 21.25

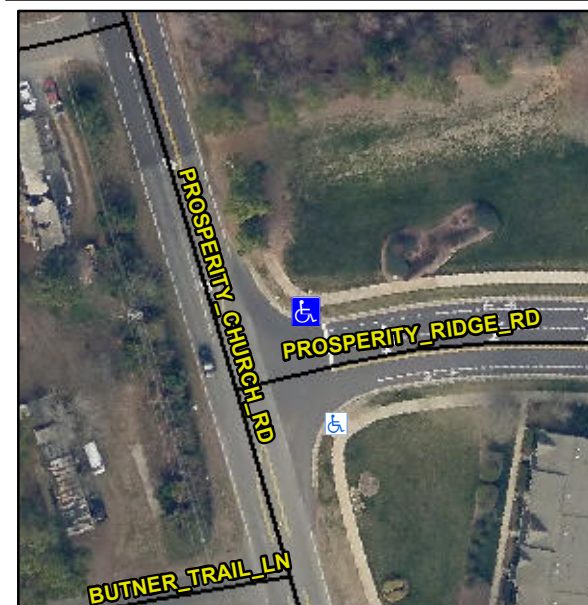
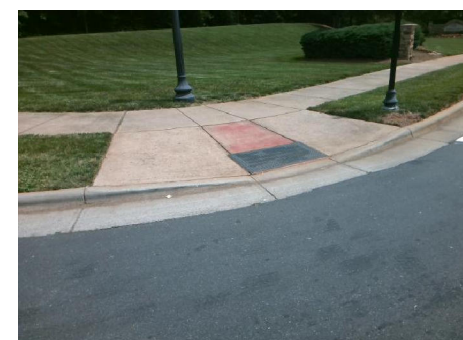
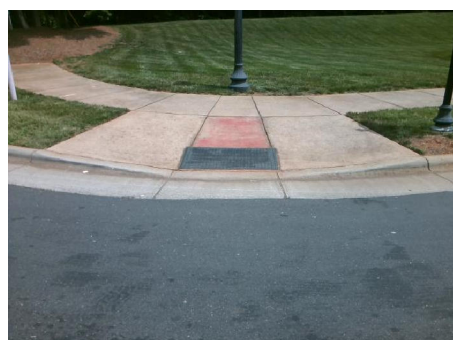
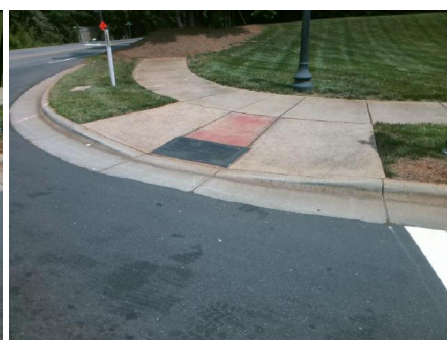
Compliance	Description	Data	Compliance	Description	Data
N/A	Ramp Length (in)	82.0	No	Ramp Slope (%)	9.2
No	Ramp Width (in)	36.0	Yes	Ramp XSlope (%)	1.7
N/A	Flare Type LT	N/A	N/A	Flare Type RT	N/A
N/A	Flare Slope LT (%)	N/A	N/A	Flare Slope RT (%)	N/A
N/A	Flare Traversable LT?	N/A	N/A	Flare Traversable RT?	N/A
N/A	Landing Length (in)	N/A	N/A	DWS Provided?	N/A
N/A	Landing Width (in)	N/A	N/A	DWS Contrast?	N/A
N/A	Landing Slope (%)	N/A	N/A	DWS Length (in)	N/A
N/A	Landing X Slope (%)	N/A	N/A	DWS Full Width?	N/A
N/A	Landing Curb? (Y/N)	N/A	N/A	DWS Offset (in)	N/A
N/A	Shared Landing?	N/A			
N/A	Gutter Ponding?	N/A	N/A	Gutter Slope (%)	N/A
N/A	Gutter Lip Ht (in)	N/A	N/A	Gutter X Slope (%)	N/A
N/A	Painted X Walk1?	No	N/A	Painted X Walk2?	N/A
	X Walk 1 Direction	To S		X Walk 2 Direction	N/A
N/A	X Walk 1 Width (in)	N/A	N/A	X Walk 2 Width (in)	N/A
	X Walk 1 Slope (%)	2.6		X Walk 2 Slope (%)	N/A
	X Walk 1 X Slope (%)	3.9		X Walk 2 X Slope (%)	N/A

N/A	Ramp inside XWalk1?	N/A	N/A	Ramp inside XWalk2?	N/A
	Road Slope (%)	N/A	N/A	Clear Space?	N/A
	Road X Slope (%)	N/A	N/A	Clear Space to XWalk (in)	N/A
N/A	Any Obstructions?	N/A	N/A	Storm Grate/Utility Hazard?	N/A
	Obstruction Type			Storm Grate/Utility Type	
		N/A			N/A
			Yes	Surface Condition? (G/P)	Good

Possible Solutions:

Remove & Replace Entire Ramp.
