Access Compliance Report

Public Rights-of-Way

(Curb Ramps)

Intersection ID: 10042138	Main Street: WITHERS_COVE_PARK_DR	Cross Street: N/A	Location: SW
ADA ID: 4692AB3C93A6	Ramp Type: PerpDiag	Initial Pass/Fail: Fail	Overall Compliance: No
Codes/Mitigation Info/Possible Solution		Field Measurements/Component Compliance	
Severity Score: 46.25

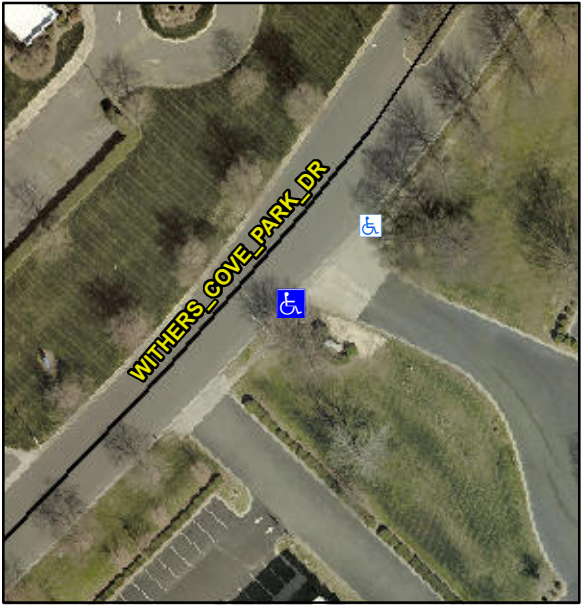
Possible Solutions:		Compliance	Description	Data	Compliance	Description	Data
	Remove & Replace Curb Ramp With Two New Directional Ramps or Equivalent.		N/A	Ramp Length (in)	60.0	No	Ramp Slope (%)	8.8
<p>Surveyor Notes:</p> <p>N/A</p> <p>PROW/ADA:</p> <p>Not Found, R304.5.1, R304.2.2, R304.5.3</p>			No	Ramp Width (in)	40.0	No	Ramp XSlope (%)	7.6
			N/A	Flare Type LT	N/A	N/A	Flare Type RT	N/A
<p>Street 1 Name</p> <p>ENTRANCE</p> <p>Stop Condition-Street 2</p> <p>None</p> <p>Street 2 Name</p> <p>WITHERS COVE PARK DR</p> <p>Stop Condition-Street 1</p> <p>None</p>			N/A	Flare Slope LT (%)	N/A	N/A	Flare Slope RT (%)	N/A
			N/A	Flare Traversable LT?	N/A	N/A	Flare Traversable RT?	N/A
<p>Total Cost:</p> <p>\$ 3200.00</p>			N/A	Landing Length (in)	N/A	N/A	DWS Provided?	N/A
			N/A	Landing Width (in)	N/A	N/A	DWS Contrast?	N/A
			N/A	Landing Slope (%)	N/A	N/A	DWS Length (in)	N/A
			N/A	Landing X Slope (%)	N/A	N/A	DWS Full Width?	N/A

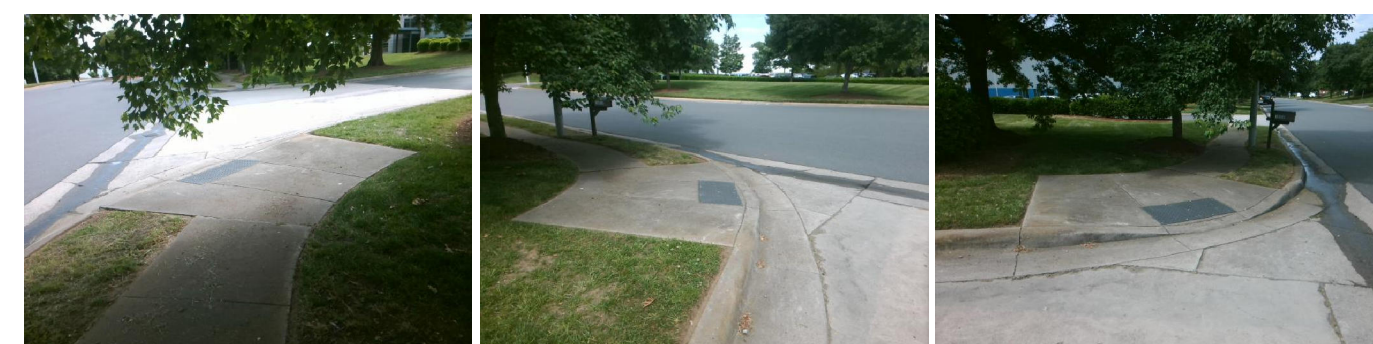
N/A	Landing Curb? (Y/N)	N/A	N/A	DWS Offset (in)	N/A
			N/A	Shared Landing?	N/A			
			N/A	Gutter Ponding?	N/A	N/A	Gutter Slope (%)	N/A
			N/A	Gutter Lip Ht (in)	N/A	N/A	Gutter X Slope (%)	N/A
			N/A	Painted X Walk1?	No	N/A	Painted X Walk2?	No
				X Walk 1 Direction	To NE		X Walk 2 Direction	To NW
			N/A	X Walk 1 Width (in)	N/A	N/A	X Walk 2 Width (in)	N/A
				X Walk 1 Slope (%)	2.3		X Walk 2 Slope (%)	2.7
				X Walk 1 X Slope (%)	2.8		X Walk 2 X Slope (%)	2.6
			N/A	Ramp inside XWalk1?	N/A	N/A	Ramp inside XWalk2?	N/A
				Road Slope (%)	3.8	N/A	Clear Space?	N/A
				Road X Slope (%)	0.0	N/A	Clear Space to XWalk (in)	N/A
			N/A	Any Obstructions?	N/A	N/A	Storm Grate/Utility Hazard?	N/A
				Obstruction Type			Storm Grate/Utility Type	
						N/A		N/A
						Yes	Surface Condition? (G/P)	Good
