Access Compliance Report

Public Rights-of-Way

(Curb Ramps)

Intersection ID: 16419	Main Street: LANTANA_AV	Cross Street: N_SHARON_AMITY_RD	Location: SE
ADA ID: 46A4E83550BD	Ramp Type: ParaDiag	Initial Pass/Fail: Fail	Overall Compliance: No
Severity Score: 12.5			
Codes/Mitigation Info/Possible Solution		Field Measurements/Component Compliance

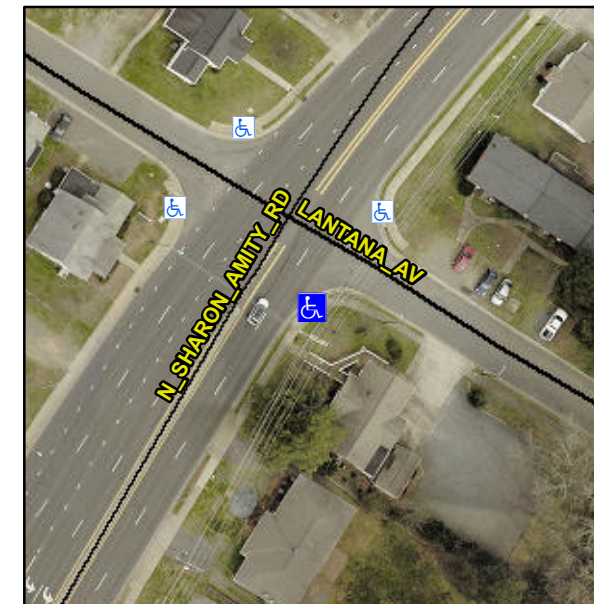
LT RP < 5%

PROW/ADA:

R304.3.2

Compliance	Description	Data	Compliance	Description	Data
N/A	Ramp Length LT (in)	56.0	N/A	Ramp Length RT (in)	66.0
Yes	Ramp Width LT (in)	83.0	Yes	Ramp Width RT (in)	85.0
Yes	Ramp Slope LT (%)	1.4	No	Ramp Slope RT (%)	8.6
Yes	Ramp XSlope LT (%)	1.8	Yes	Ramp XSlope RT (%)	0.2
N/A	Landing Length (in)	N/A	N/A	DWS Provided?	N/A
N/A	Landing Width (in)	N/A	N/A	DWS Contrast?	N/A
N/A	Landing Slope (%)	N/A	N/A	DWS Length (in)	N/A
N/A	Landing X Slope (%)	N/A	N/A	DWS Full Width?	N/A
N/A	Landing Curb? (Y/N)	N/A	N/A	DWS Offset (in)	N/A
N/A	Shared Landing?	N/A			
N/A	Gutter Ponding?	N/A	N/A	Gutter Slope (%)	N/A
N/A	Gutter Lip Ht (in)	N/A	N/A	Gutter X Slope (%)	N/A
N/A	Painted X Walk1?	No	N/A	Painted X Walk2?	No
	X Walk 1 Direction	To NE		X Walk 2 Direction	To NW
N/A	X Walk 1 Width (in)	N/A	N/A	X Walk 2 Width (in)	N/A
	X Walk 1 Slope (%)	1.2		X Walk 2 Slope (%)	0.6
	X Walk 1 X Slope (%)	4.6		X Walk 2 X Slope (%)	0.9
N/A	Ramp inside XWalk1?	N/A	N/A	Ramp inside XWalk2?	N/A

Road Slope (%)	1.9	N/A	Clear Space?	N/A
	Road X Slope (%)	0.9	N/A	Clear Space to XWalk (in)	N/A
N/A	Any Obstructions?	N/A	N/A	Storm Grate/Utility Hazard?	N/A
	Obstruction Type			Storm Grate/Utility Type	
		N/A			N/A
			Yes	Surface Condition? (G/P)	Good
			N/A	Curb Slope (%)	0.0

Possible Solutions:

Remove & Replace Curb Ramp With Two New Directional Ramps or Equivalent.

Total Cost: \$ 3200.00
