Access Compliance Report Public Rights-of-Way (Curb Ramps)

0 1	MONTEITH DD	1			
Intersection ID: 7556	Main Street: GEORGETOWN_DR			Cross Street: MONTEITH_DR					Location:	NW
ADA ID: 46A68021DD7C	Ramp Type: Perp			Initial	Initial Pass/Fail: Fail Overall Compliance: N				o Severity Score:	10
Codes/Mitigation Info/Possible Solution				Field Measurements/Component Compliance						
		Possible Solutions:		Compliance Description			Data Compliance Description			
	A star	Remove & Replace En	tire Ramp).	N/A	Ramp Length (in)	29.0	Yes	Ramp Slope (%)	5.1
States - 1 total	and a second		•		No	Ramp Width (in)	47.5	No	Ramp XSlope (%)	3.5
A TABLE IN THE TO	The second				N/A	Flare Type LT	N/A	N/A	Flare Type RT	N/A
The line of		1			N/A	Flare Slope LT (%)	N/A	N/A	Flare Slope RT (%)	N/A
					N/A	Flare Traversable LT?	N/A	N/A	Flare Traversable RT?	N/A
	1				N/A	Landing Length (in)	N/A	N/A	DWS Provided?	N/A
		Surveyor Notes:			N/A	Landing Width (in)	N/A	N/A	DWS Contrast?	N/A
		N/A			N/A	Landing Slope (%)	N/A	N/A	DWS Length (in)	N/A

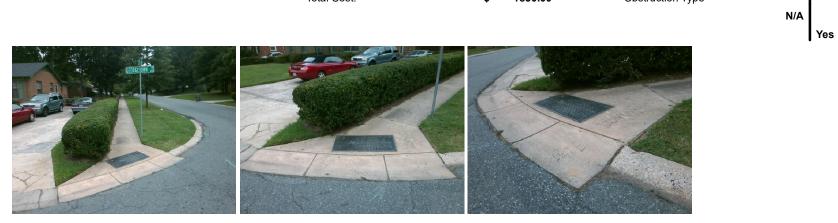
the part				N/A	Landing X Slope (%)	N/A	N/A	DWS Full Width?	N/A
EU EU	1				N/A	Landing Curb? (Y/N)	N/A	N/A	DWS Offset (in)	N/A
CEOLICE	Photo A				N/A	Shared Landing?	N/A			
	1200	PROW/ADA:			N/A	Gutter Ponding?	N/A	N/A	Gutter Slope (%)	N/A
	W C	Not Found, R304.5.1,	R304.5.3		N/A	Gutter Lip Ht (in)	0.5	N/A	Gutter X Slope (%)	N/A
	1861				N/A	Painted X Walk1?	No	N/A	Painted X Walk2?	N/A
A DECEMBER OF					X Walk 1 Direction	To S		X Walk 2 Direction	N/A	
				N/A	X Walk 1 Width (in)	N/A	N/A	X Walk 2 Width (in)	N/A	
Street 1 Name GEORG	ETOWN DR	_				X Walk 1 Slope (%)	1.7		X Walk 2 Slope (%)	N/A
Stop Condition-Street 2	StopSign					X Walk 1 X Slope (%)	2.7		X Walk 2 X Slope (%)	N/A
Street 2 Name	N/A				N/A	Ramp inside XWalk1?	N/A	N/A	Ramp inside XWalk2?	N/A
Stop Condition-Street 1	N/A					Road Slope (%)	N/A	N/A	Clear Space?	N/A
						Road X Slope (%)	N/A	N/A	Clear Space to XWalk (in)	N/A
					N/A	Any Obstructions?	N/A	N/A	Storm Grate/Utility Hazard?	N/A

Total Cost:	\$	1850.00		Obstruction Type			Storm Grate/Utility Type	
						•••	N/A			N/A
