# Access Compliance Report

## Public Rights-of-Way

### (Curb Ramps)

Intersection ID: 15736	Main Street: CHEROKEE_PL	Cross Street: LLEWELLYN_PL	Location: SE
ADA ID: 46D531EA4269	Ramp Type: PerpDiag	Initial Pass/Fail: Fail	Overall Compliance: No
Codes/Mitigation Info/Possible Solution		Field Measurements/Component Compliance	
Severity Score: 21.25

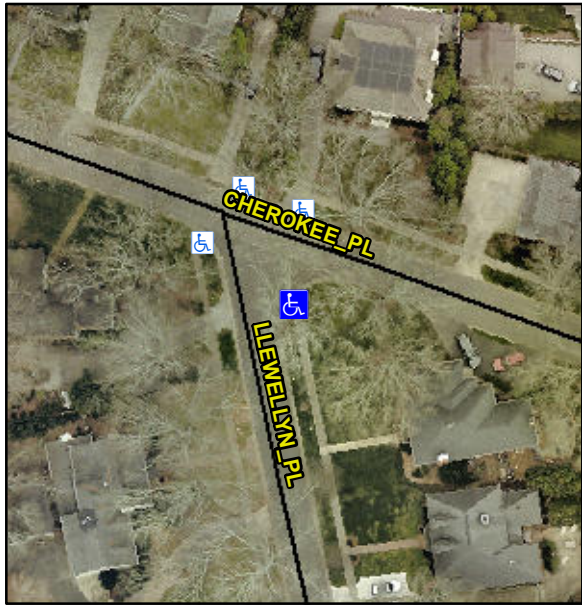
Compliance	Description	Data	Compliance	Description	Data
N/A	Ramp Length (in)	58.0	No	Ramp Slope (%)	9.1
No	Ramp Width (in)	44.0	Yes	Ramp XSlope (%)	1.3
N/A	Flare Type LT	N/A	N/A	Flare Type RT	N/A
N/A	Flare Slope LT (%)	N/A	N/A	Flare Slope RT (%)	N/A
N/A	Flare Traversable LT?	N/A	N/A	Flare Traversable RT?	N/A
N/A	Landing Length (in)	N/A	N/A	DWS Provided?	N/A
N/A	Landing Width (in)	N/A	N/A	DWS Contrast?	N/A
N/A	Landing Slope (%)	N/A	N/A	DWS Length (in)	N/A
N/A	Landing X Slope (%)	N/A	N/A	DWS Full Width?	N/A
N/A	Landing Curb? (Y/N)	N/A	N/A	DWS Offset (in)	N/A
N/A	Shared Landing?	N/A			
N/A	Gutter Ponding?	N/A	N/A	Gutter Slope (%)	N/A
N/A	Gutter Lip Ht (in)	N/A	N/A	Gutter X Slope (%)	N/A
N/A	Painted X Walk1?	No	N/A	Painted X Walk2?	No
	X Walk 1 Direction	To N		X Walk 2 Direction	To NW
N/A	X Walk 1 Width (in)	N/A	N/A	X Walk 2 Width (in)	N/A
	X Walk 1 Slope (%)	1.6		X Walk 2 Slope (%)	2.1
	X Walk 1 X Slope (%)	4.2		X Walk 2 X Slope (%)	0.8

N/A	Ramp inside XWalk1?	N/A	N/A	Ramp inside XWalk2?	N/A
	Road Slope (%)	0.1	N/A	Clear Space?	N/A
	Road X Slope (%)	3.8	N/A	Clear Space to XWalk (in)	N/A
N/A	Any Obstructions?	N/A	N/A	Storm Grate/Utility Hazard?	N/A
	Obstruction Type			Storm Grate/Utility Type	
		N/A			N/A
			Yes	Surface Condition? (G/P)	Good

Possible Solutions:

Remove & Replace Curb Ramp With Two New Directional Ramps or Equivalent.
