Access Compliance Report

Public Rights-of-Way

(Curb Ramps)

Intersection ID: 12073	Main Street: E_11TH_ST	Cross Street: N_CALDWELL_ST	Location: N
ADA ID: 46DBE2836517	Ramp Type: PerpDiag	Initial Pass/Fail: Fail	Overall Compliance: No
			Severity Score: 21.25

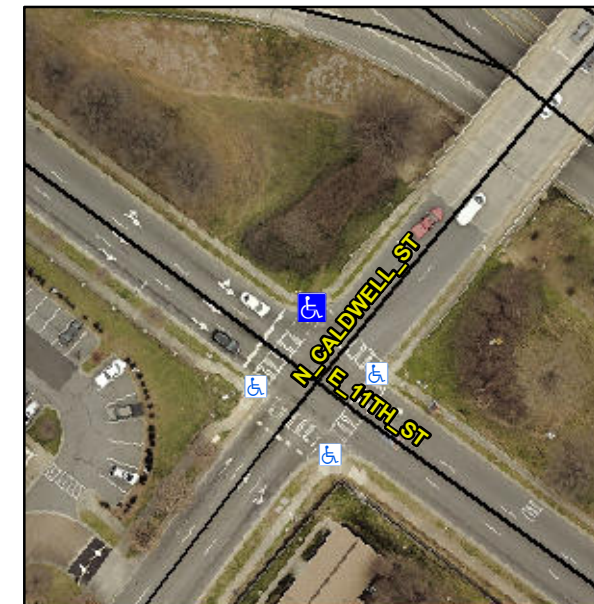
Not Found, R304.5.1, R304.2.2

Compliance	Description	Data	Compliance	Description	Data
N/A	Ramp Length (in)	84.0	No	Ramp Slope (%)	9.7
No	Ramp Width (in)	38.0	Yes	Ramp XSlope (%)	0.3
N/A	Flare Type LT	N/A	N/A	Flare Type RT	N/A
N/A	Flare Slope LT (%)	N/A	N/A	Flare Slope RT (%)	N/A
N/A	Flare Traversable LT?	N/A	N/A	Flare Traversable RT?	N/A
N/A	Landing Length (in)	N/A	N/A	DWS Provided?	N/A
N/A	Landing Width (in)	N/A	N/A	DWS Contrast?	N/A
N/A	Landing Slope (%)	N/A	N/A	DWS Length (in)	N/A
N/A	Landing X Slope (%)	N/A	N/A	DWS Full Width?	N/A
N/A	Landing Curb? (Y/N)	N/A	N/A	DWS Offset (in)	N/A
N/A	Shared Landing?	N/A			
N/A	Gutter Ponding?	N/A	N/A	Gutter Slope (%)	N/A
N/A	Gutter Lip Ht (in)	N/A	N/A	Gutter X Slope (%)	N/A
N/A	Painted X Walk1?	Yes	N/A	Painted X Walk2?	Yes
	X Walk 1 Direction	To SW		X Walk 2 Direction	To SE
N/A	X Walk 1 Width (in)	111.0	N/A	X Walk 2 Width (in)	100.0
	X Walk 1 Slope (%)	2.7		X Walk 2 Slope (%)	3.6
	X Walk 1 X Slope (%)	4.0		X Walk 2 X Slope (%)	3.1

N/A	Ramp inside XWalk1?	Yes	N/A	Ramp inside XWalk2?	Yes
	Road Slope (%)	2.1	N/A	Clear Space?	N/A
	Road X Slope (%)	4.6	N/A	Clear Space to XWalk (in)	N/A
N/A	Any Obstructions?	N/A	N/A	Storm Grate/Utility Hazard?	N/A
	Obstruction Type			Storm Grate/Utility Type	
		N/A			N/A
		Yes		Surface Condition? (G/P)	Good

Remove & Replace Curb Ramp With Two New Directional Ramps or Equivalent.
