Access Compliance Report

Public Rights-of-Way

(Curb Ramps)

| Intersection ID: 16470 | Main Street: E_INDEPENDENCE_BV | Cross Street: FARMINGDALE DR | Location: S |

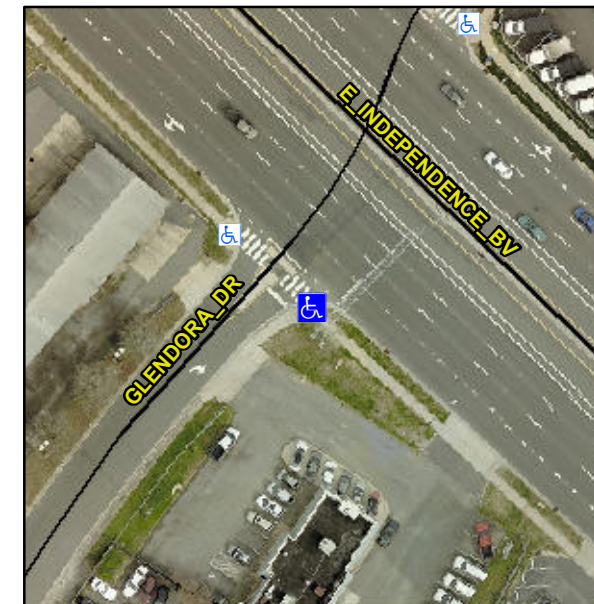
| Compliance | Description | Data | Compliance | Description | Data |
|---|---|---|---|---|---|
| N/A | Ramp Length (in) | 40.0 | No | Ramp Slope (%) | 9.3 |
| Yes | Ramp Width (in) | 58.5 | Yes | Ramp XSlope (%) | 1.5 |

Remove & Replace Entire Ramp.

R304.2.2
