Access Compliance Report

Public Rights-of-Way

(Curb Ramps)

Intersection ID: 4523	Main Street: FELDBANK_DR	Cross Street: TRINITY_RD	Location: SE
ADA ID: 46DF56ECFA75	Ramp Type: Perp	Initial Pass/Fail: Fail	Overall Compliance: No
Severity Score: 18.75			
Codes/Mitigation Info/Possible Solution		Field Measurements/Component Compliance

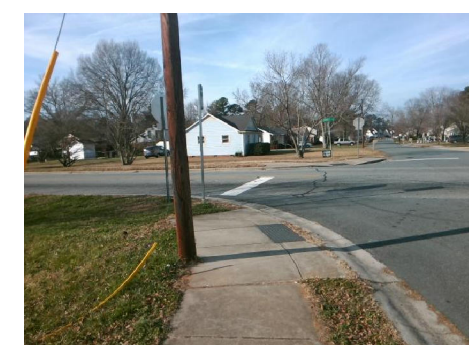
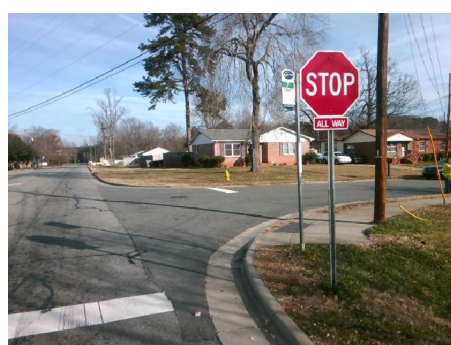
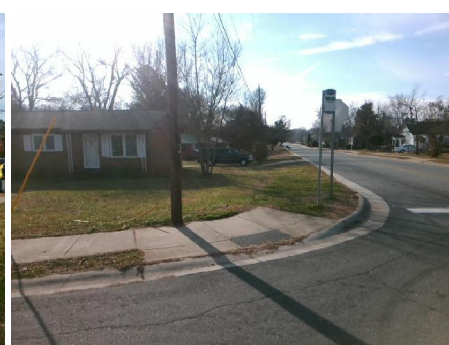
Not Found, R304.5.1, R304.5.3

Compliance	Description	Data	Compliance	Description	Data
N/A	Ramp Length (in)	86.0	Yes	Ramp Slope (%)	5.1
No	Ramp Width (in)	35.5	No	Ramp XSlope (%)	2.9
N/A	Flare Type LT	N/A	N/A	Flare Type RT	N/A
N/A	Flare Slope LT (%)	N/A	N/A	Flare Slope RT (%)	N/A
N/A	Flare Traversable LT?	N/A	N/A	Flare Traversable RT?	N/A
N/A	Landing Length (in)	N/A	N/A	DWS Provided?	N/A
N/A	Landing Width (in)	N/A	N/A	DWS Contrast?	N/A
N/A	Landing Slope (%)	N/A	N/A	DWS Length (in)	N/A
N/A	Landing X Slope (%)	N/A	N/A	DWS Full Width?	N/A
N/A	Landing Curb? (Y/N)	N/A	N/A	DWS Offset (in)	N/A
N/A	Shared Landing?	N/A			
N/A	Gutter Ponding?	N/A	N/A	Gutter Slope (%)	N/A
N/A	Gutter Lip Ht (in)	N/A	N/A	Gutter X Slope (%)	N/A
N/A	Painted X Walk1?	No	N/A	Painted X Walk2?	N/A
	X Walk 1 Direction	To W		X Walk 2 Direction	N/A
N/A	X Walk 1 Width (in)	N/A	N/A	X Walk 2 Width (in)	N/A
	X Walk 1 Slope (%)	2.5		X Walk 2 Slope (%)	N/A
	X Walk 1 X Slope (%)	1.1		X Walk 2 X Slope (%)	N/A

N/A	Ramp inside XWalk1?	N/A	N/A	Ramp inside XWalk2?	N/A
	Road Slope (%)	N/A	N/A	Clear Space?	N/A
	Road X Slope (%)	N/A	N/A	Clear Space to XWalk (in)	N/A
N/A	Any Obstructions?	N/A	N/A	Storm Grate/Utility Hazard?	N/A
	Obstruction Type			Storm Grate/Utility Type	
		N/A			N/A
			Yes	Surface Condition? (G/P)	Good

Remove & Replace Entire Ramp.

Total Cost: \$ 1850.00
