Access Compliance Report

Public Rights-of-Way

(Curb Ramps)

| Intersection ID: 16298 | Main Street: W_TYVOLA_RD | Cross Street: YORKMONT_RD | Location: SW |

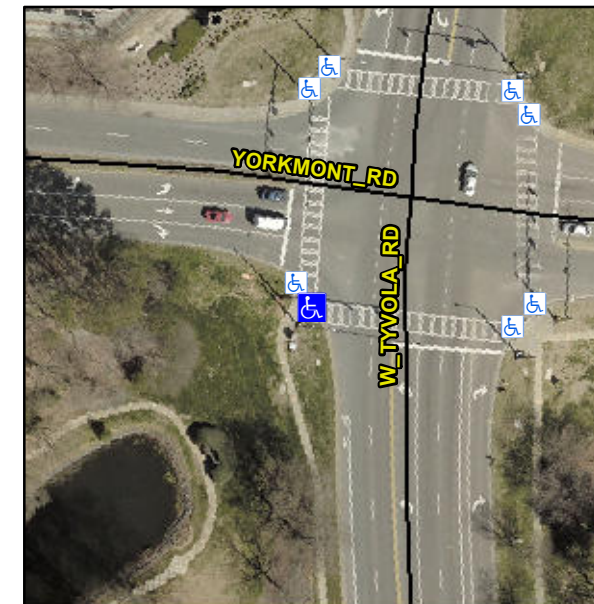
| ADA ID: 46E1CFA21197 | Ramp Type: Perp | Initial Pass/Fail: Fail | Overall Compliance: No |
| | | Severity Score: 35 | |

R304.5.1, R304.2.2, R304.5.3

| Compliance | Description | Data | Compliance | Description | Data |
|---|---|---|---|---|---|
| N/A | Ramp Length (in) | 78.0 | No | Ramp Slope (%) | 15.7 |
| No | Ramp Width (in) | 45.0 | No | Ramp XSlope (%) | 2.6 |

Possible Solutions:

Remove & Replace Entire Ramp.
